Your Inspection Report

3 W. Summit St.
Chagrin Falls, OH 44022

INSPECTION DATE:
Friday, August 16, 2019

RE: Report No. 1972
3 W. Summit St.
Chagrin Falls, OH
44022

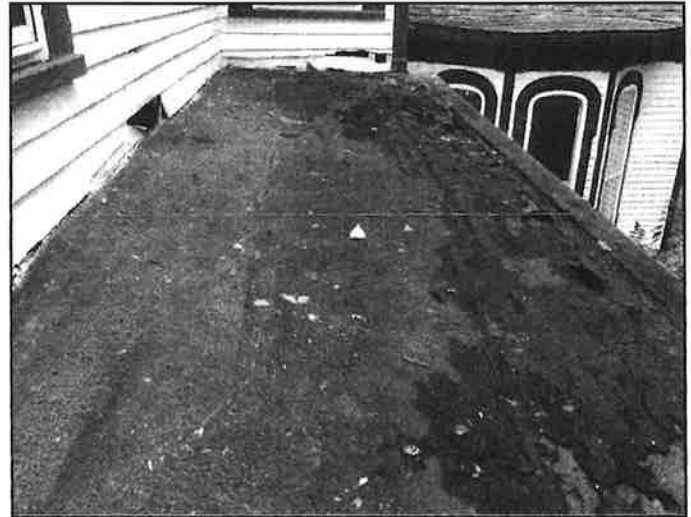
81. Debris / Worn

2. Condition: • Flat roofs around house in poor condition. Holes / rot noted on front porch. Poorly flashed and missing / worn out materials on others.

Implication(s): Water Damage to Contents / Structure

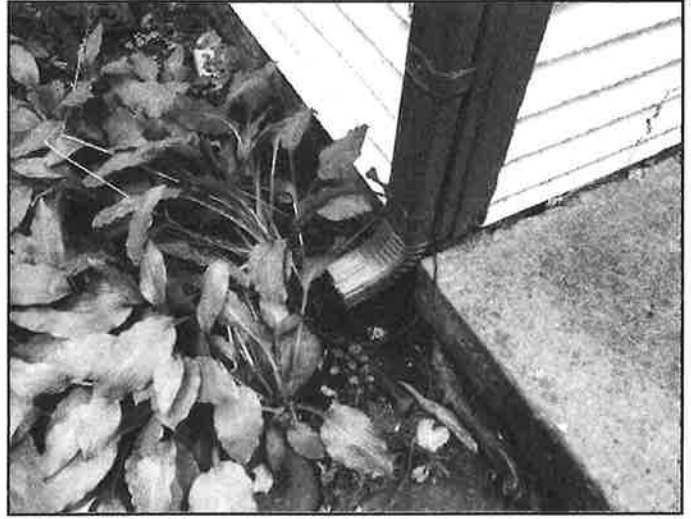
95. Discharge too close to building

8. Condition: • Discharge too close to building

Implication(s): Chance of water damage to contents, finishes and/or structure

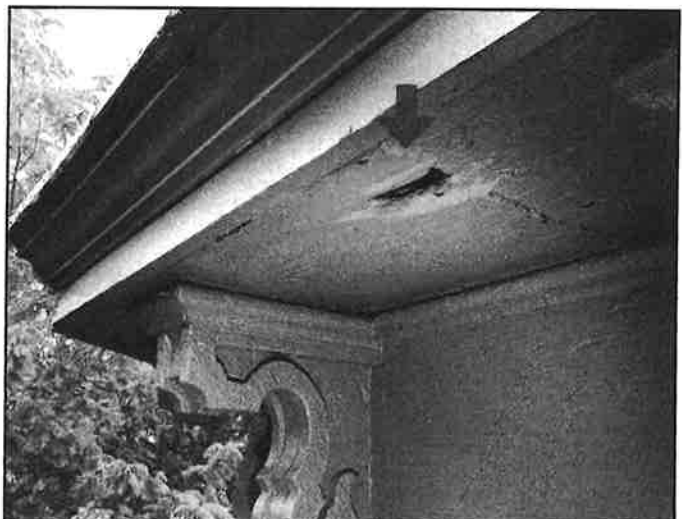
99. Rot

11. Condition: • Rot

Multiple areas around home with rot noted on trim. Severe rot to soffit / trim of widows walk.

Implication(s): Chance of water damage to contents, finishes and/or structure | Material deterioration

Task: Replace

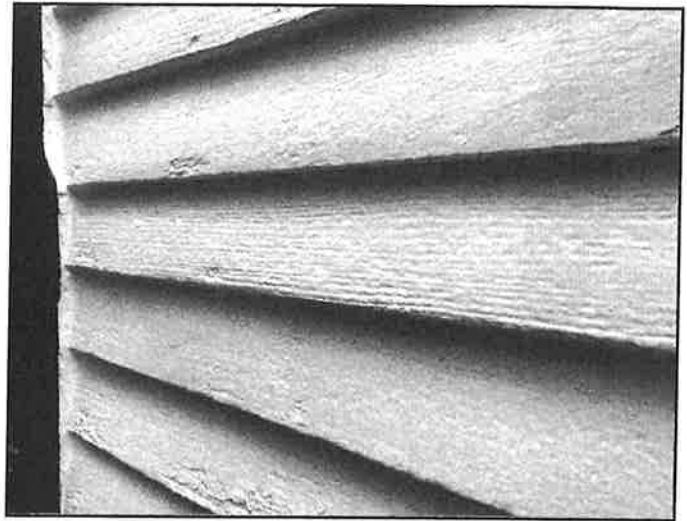
105.

12. Condition: • Appears the entire house / trim was blasted to remove old paint. Blasting damages wood and leaves scarring as seen throughout home.

Implication(s): Accelerated Material Deterioration

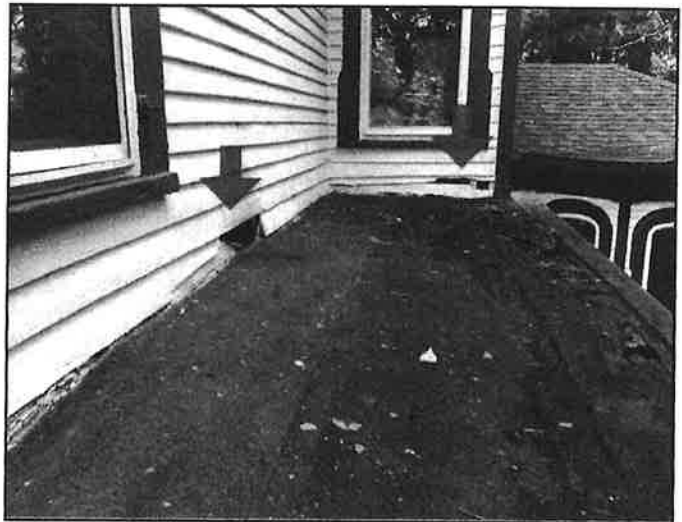
107. *Cracked, split or broken*

13. **Condition:** • Cracked, split or broken

Multiple boards damaged throughout exterior. Appears animals may be entering large hole in siding above porch.

Implication(s): Chance of water damage to contents, finishes and/or structure

Task: Replace

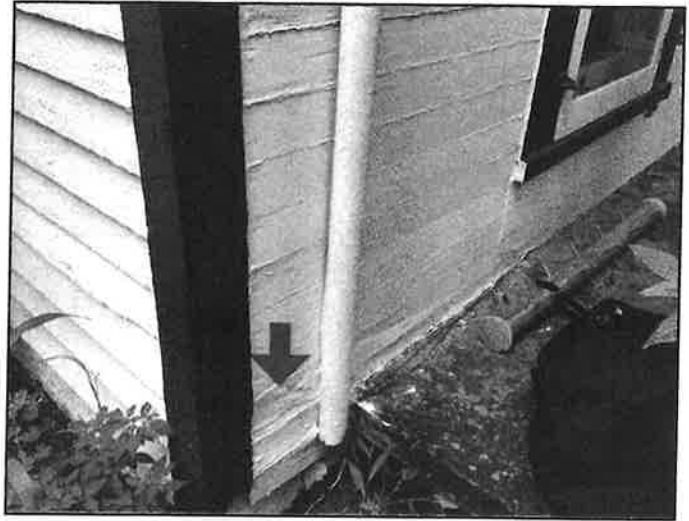
112. Rot

14. Condition: • Rot

Implication(s): Weakened structure | Material deterioration

Task: Replace

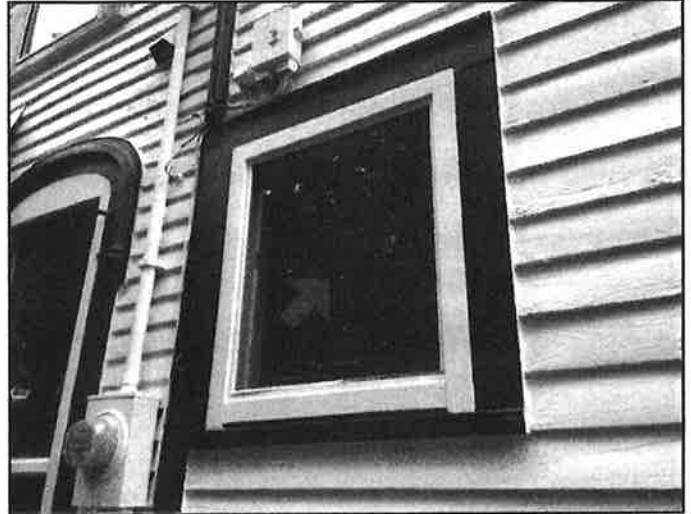
115. Cracked

15. Condition: • Cracked

Multiple windows with cracked glass noted.

Task: Replace

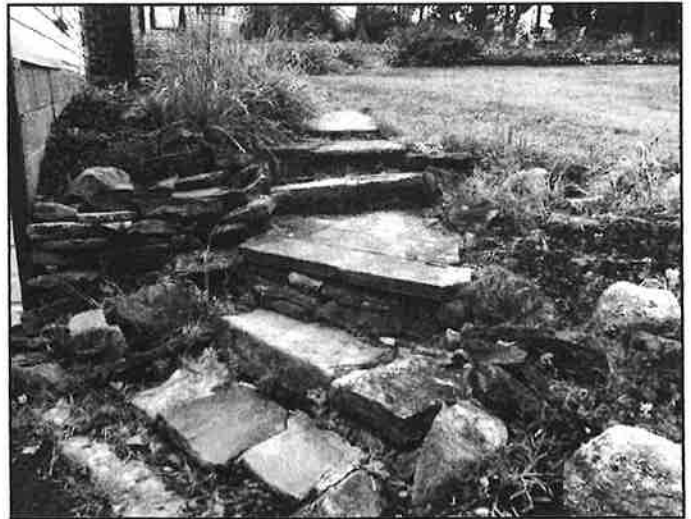
127. Uneven (trip hazard)

21. Condition: • Uneven (trip hazard)

Multiple stone walkways and patios around home in poor condition. Porch foundations have deteriorated / missing masonry. Walkways uneven / slippery. Walkway from garage has multiple loose stones and stair rise / run improper.

Task: Repair or replace

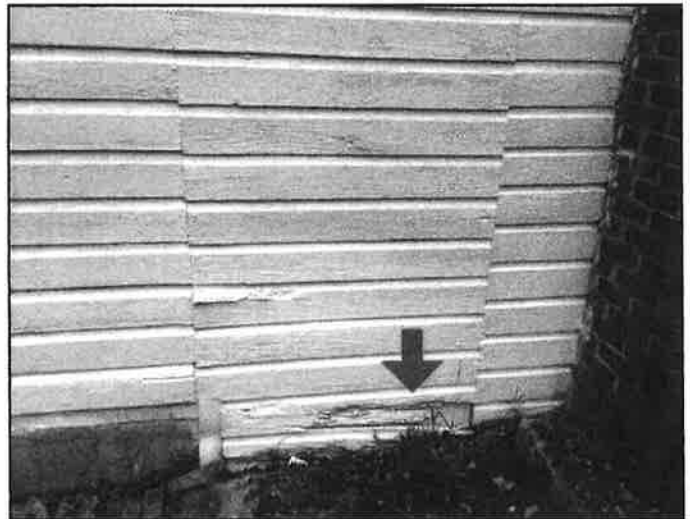
135. Loose Steps / Rot

22. Condition: • Garage / guest house in poor condition. Whole building is racked toward street. Multiple large cracks through foundation. Wood siding / trim damaged and missing in places. Flat roof is sagged toward middle. Visible wiring in need of corrections.

Implication(s): Further Deterioration / Structural Collapse

Task: Repair / Replace

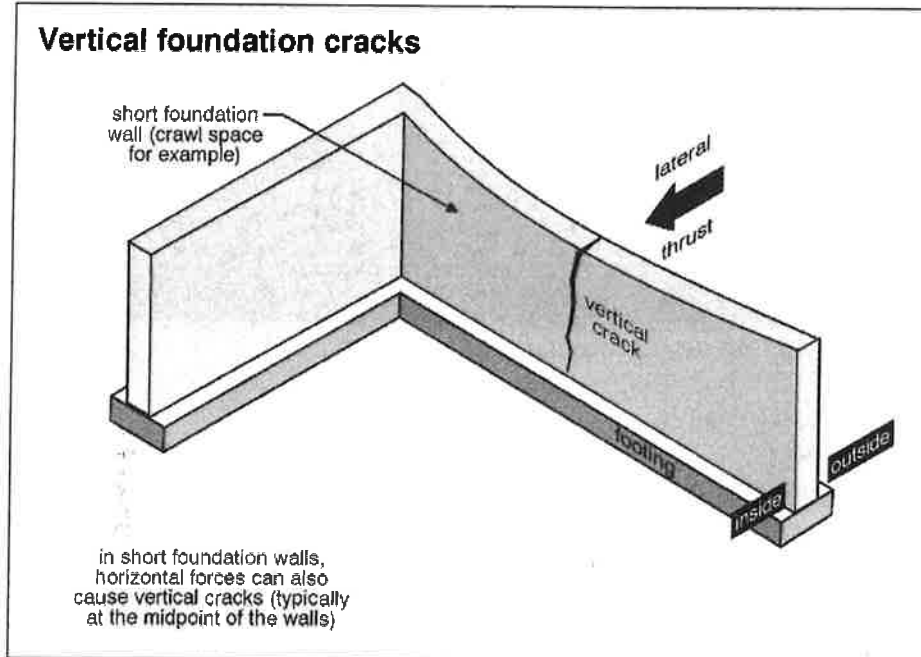
149. Cracked

23. Condition: • Cracked

Cracks noted to stone foundation walls.

Implication(s): Chance of water damage to contents, finishes and/or structure | Weakened structure

Task: Repair / Monitor

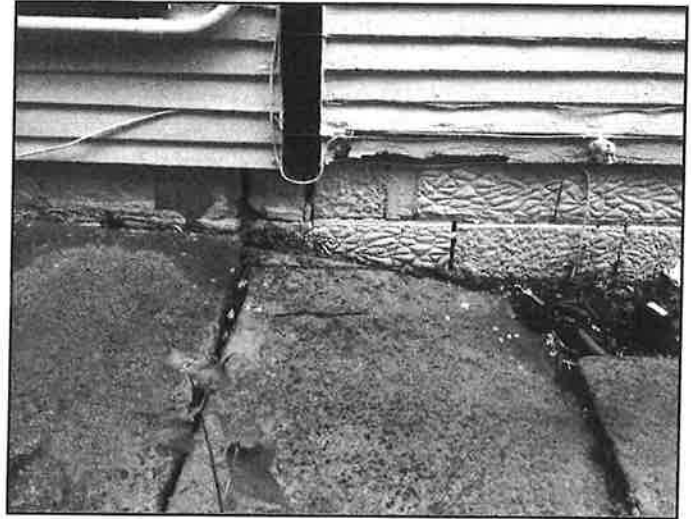
152. Mortar deteriorated or missing

26. Condition: • Mortar deteriorated or missing

Task: Repair

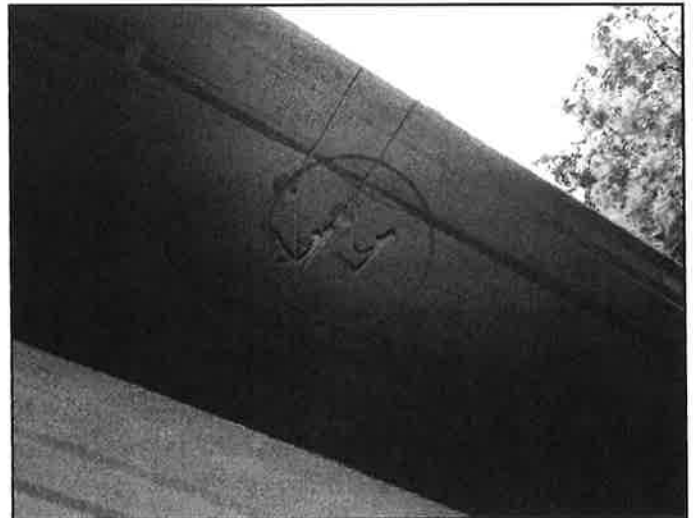
163. Basement

33. Condition: • Open splices
Implication(s): Electric shock | Fire hazard
Location: Various
Task: Correct

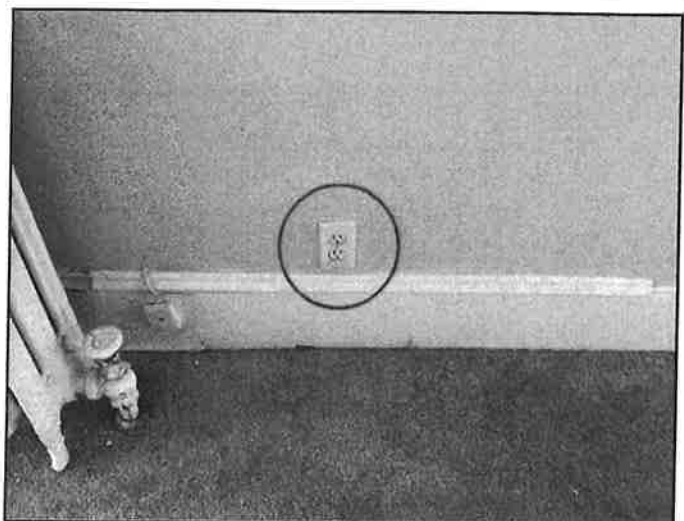
170. Ungrounded

38. Condition: • Ungrounded

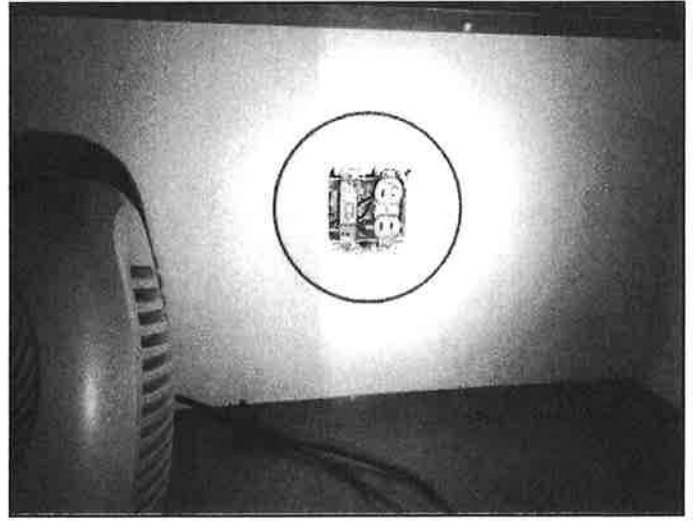
178. Missing

42. Condition: • Missing

Task: Replace

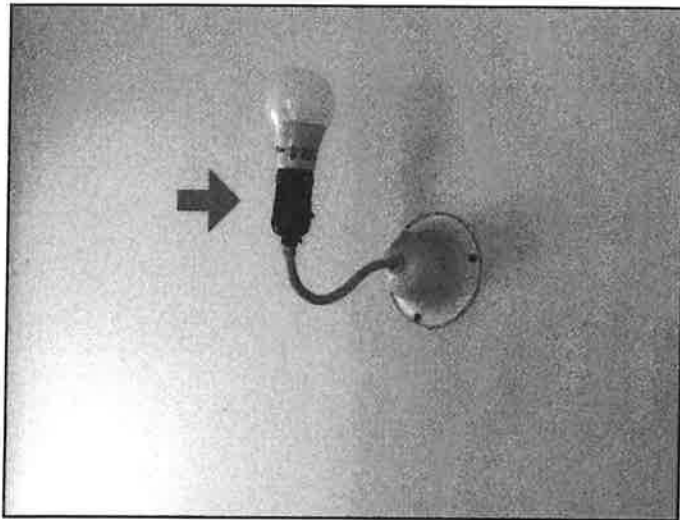
44. Condition: • Obsolete

Implication(s): Electric shock | Fire hazard

Task: Replace

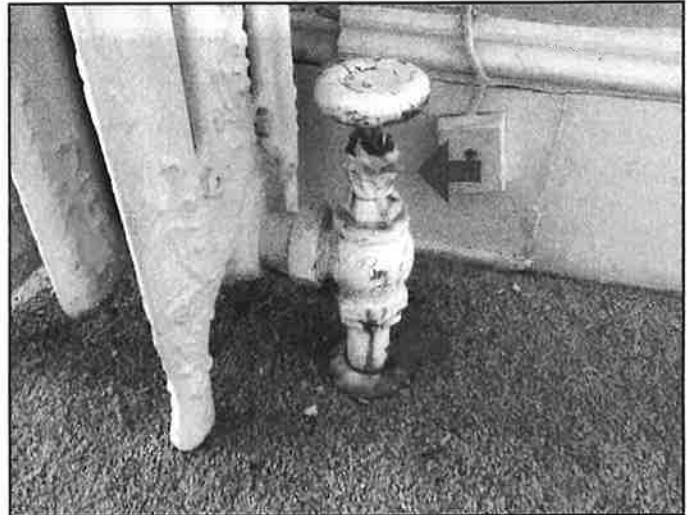
196. Leaking

53. Condition: • Leak

One radiator actively leaking. Other radiators with signs of leaks.

Implication(s): Chance of water damage to contents, finishes and/or structure

Task: Repair

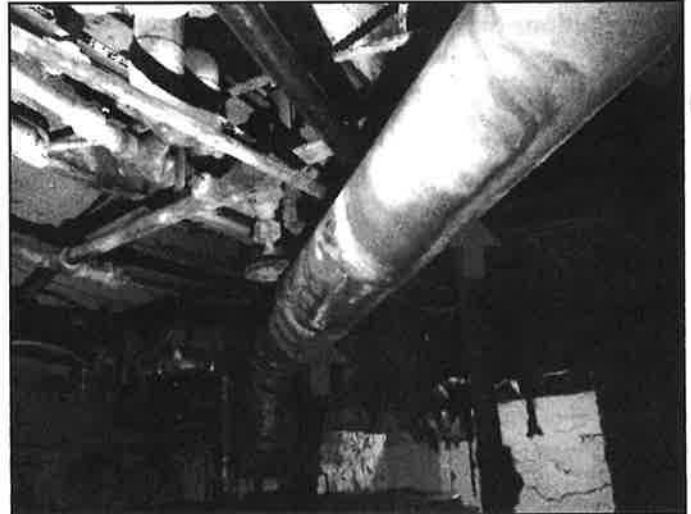
213. Rust

61. Condition: • Rust

Water tank in poor condition for age. Rust noted throughout tank, gas line and vent pipe.

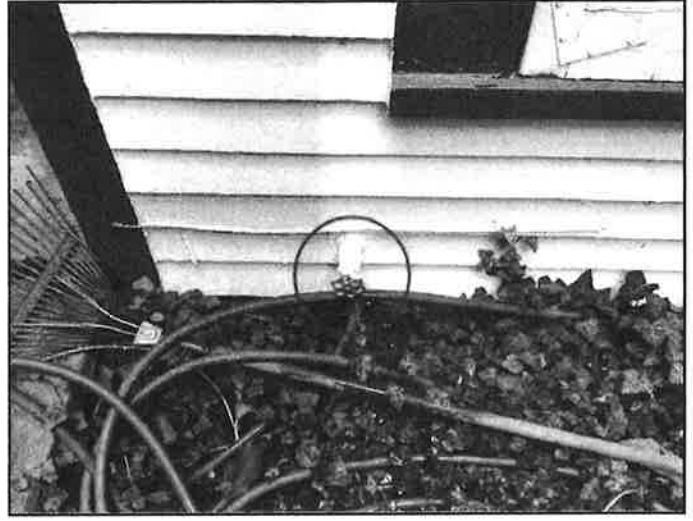
221. Missing Handle

66. Condition: • Not Frost Free

Implication(s): Chance of water damage to contents, finishes and/or structure

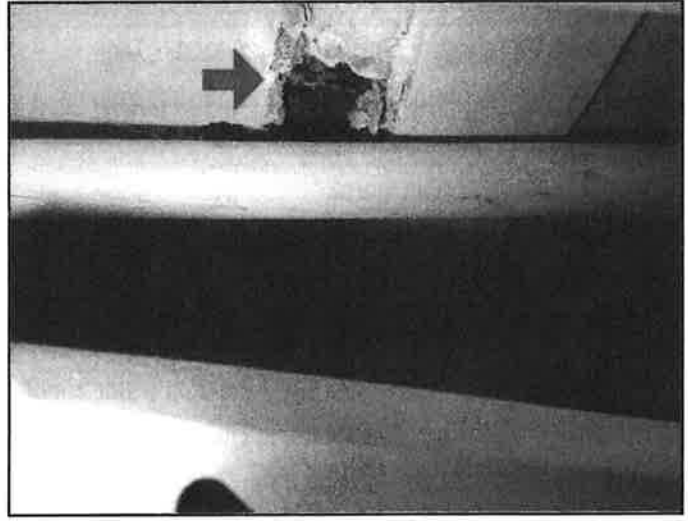
228. Water Damage

72. Condition: • Damage

Closet ceiling and wall damaged.

Implication(s): Damage or physical injury due to falling materials

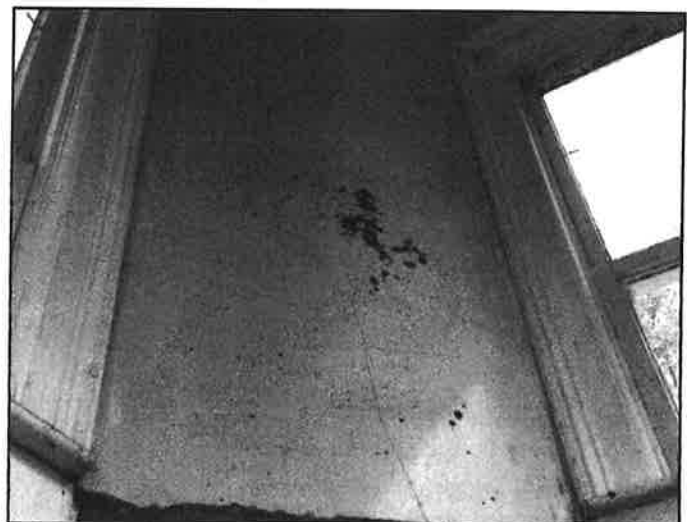
233. Possible mold

Condition: • Possible mold

Probable mold noted inside widows walk.

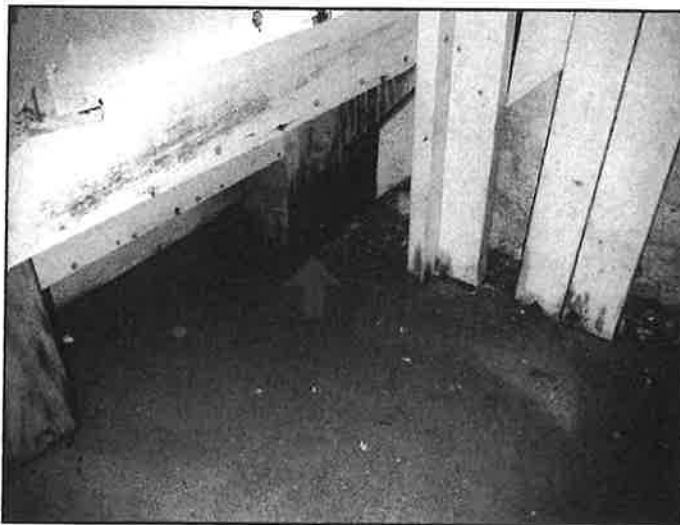
249. Water Stains

Condition: • Dampness on floor or walls

Implication(s): Chance of water damage to contents, finishes and/or structure | Material deterioration

Task: Further evaluation
