Memo

TO	FROM
Robert Jamieson, Chief Administrative Officer	Alice L. Sloan, Historic Preservation Specialist
COMPANY	DATE
Village of Chagrin Falls, Ohio	14 November 2019
RE:	CC:
<u>3 West Summit Street</u> , Chagrin Falls, Ohio	Elizabeth Corbin Murphy, FAIA, Perspectus

Background

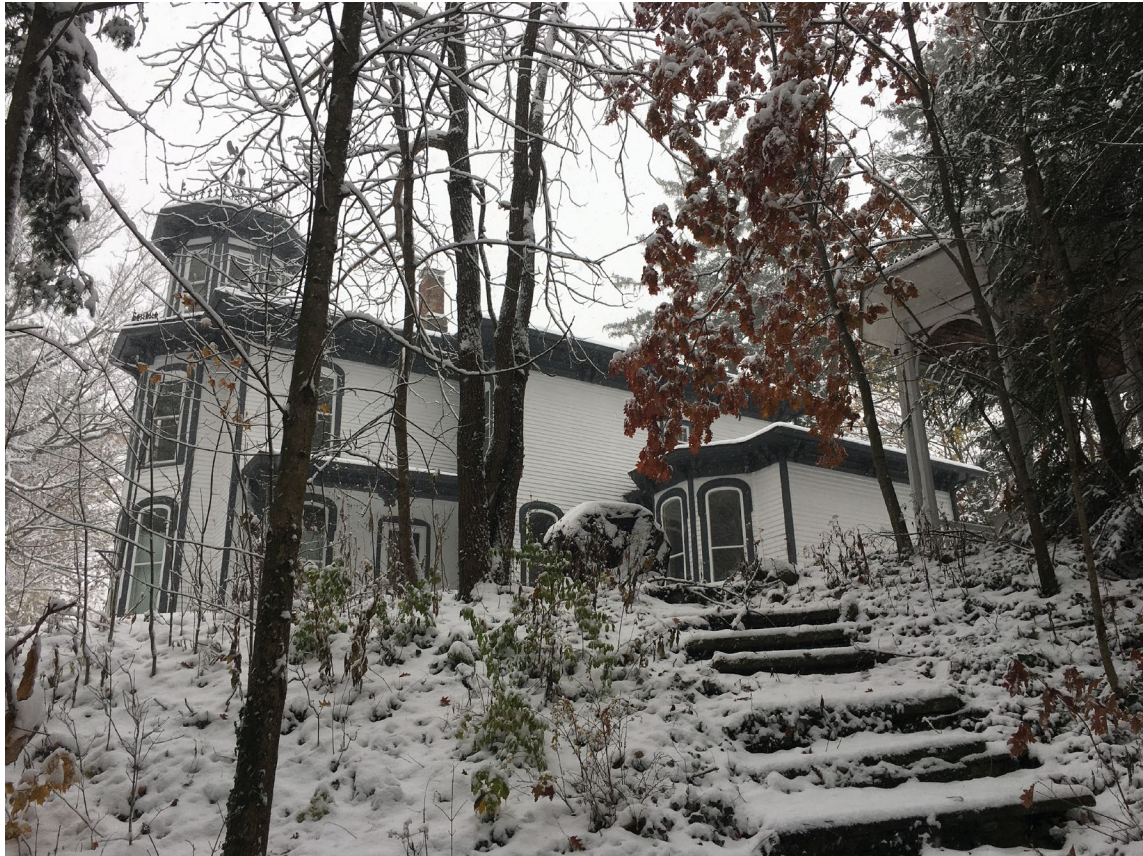
Approach to the main house from the southeast.

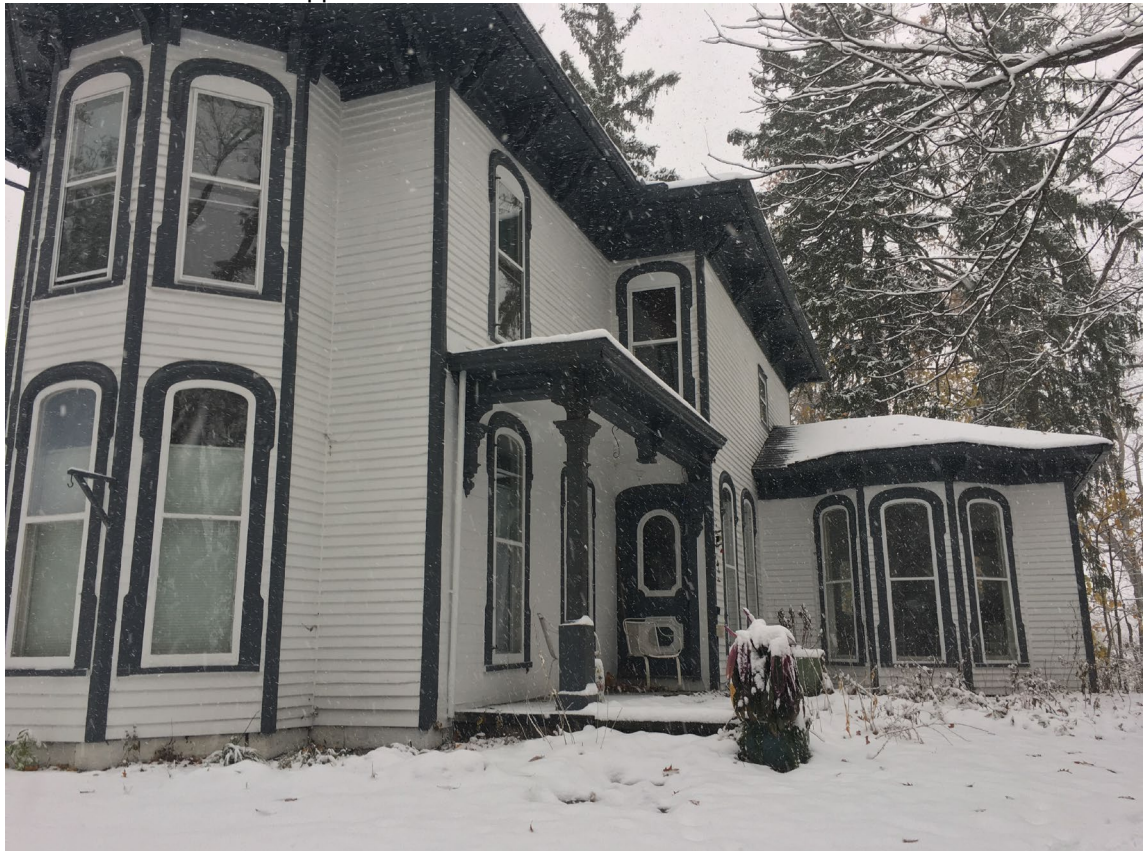
Partial south elevation of main house.

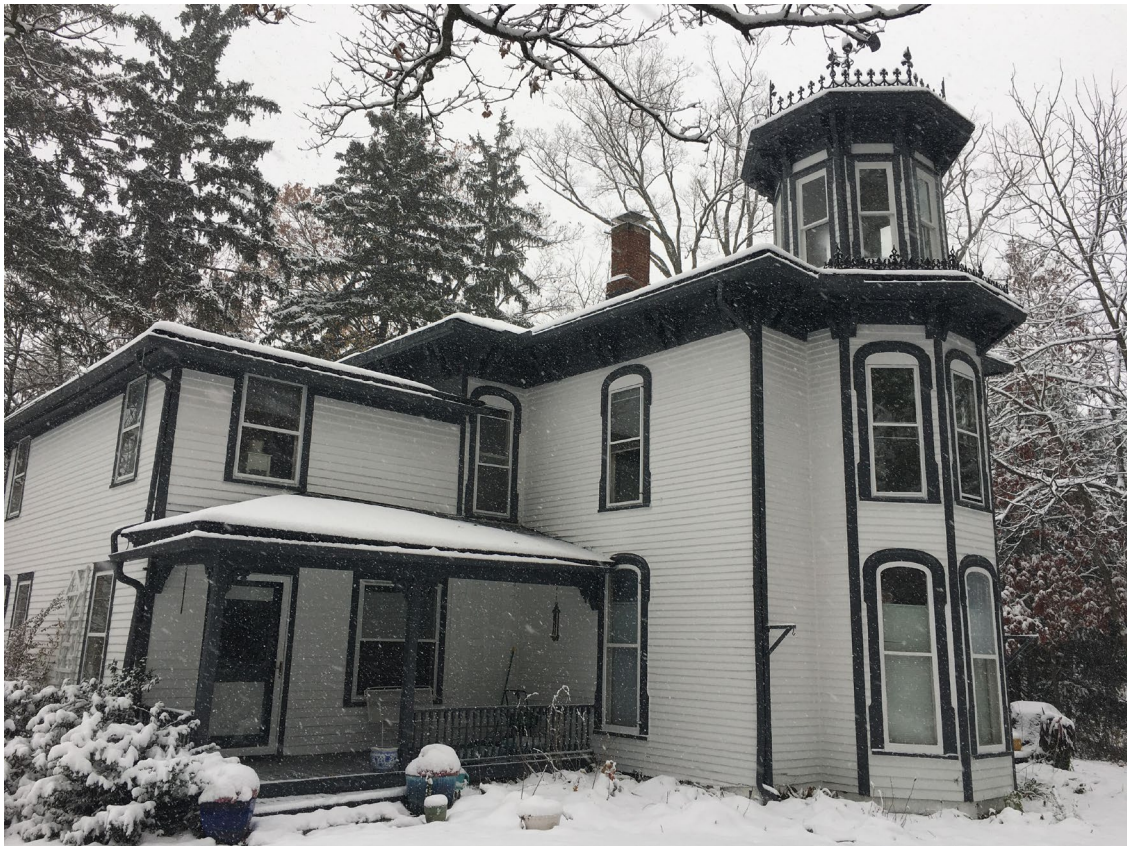
Partial south and west elevations of main house. The addition on the left dates to before 1920.

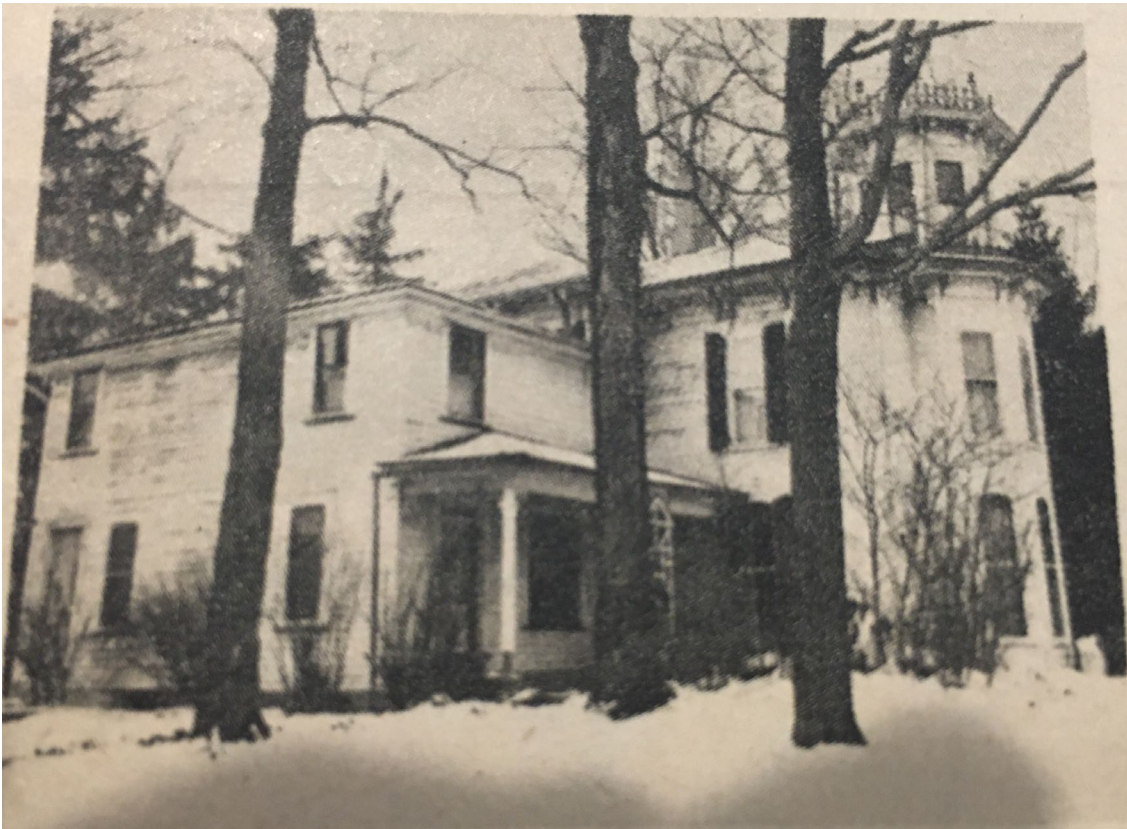
Partial south and west elevations of main house.

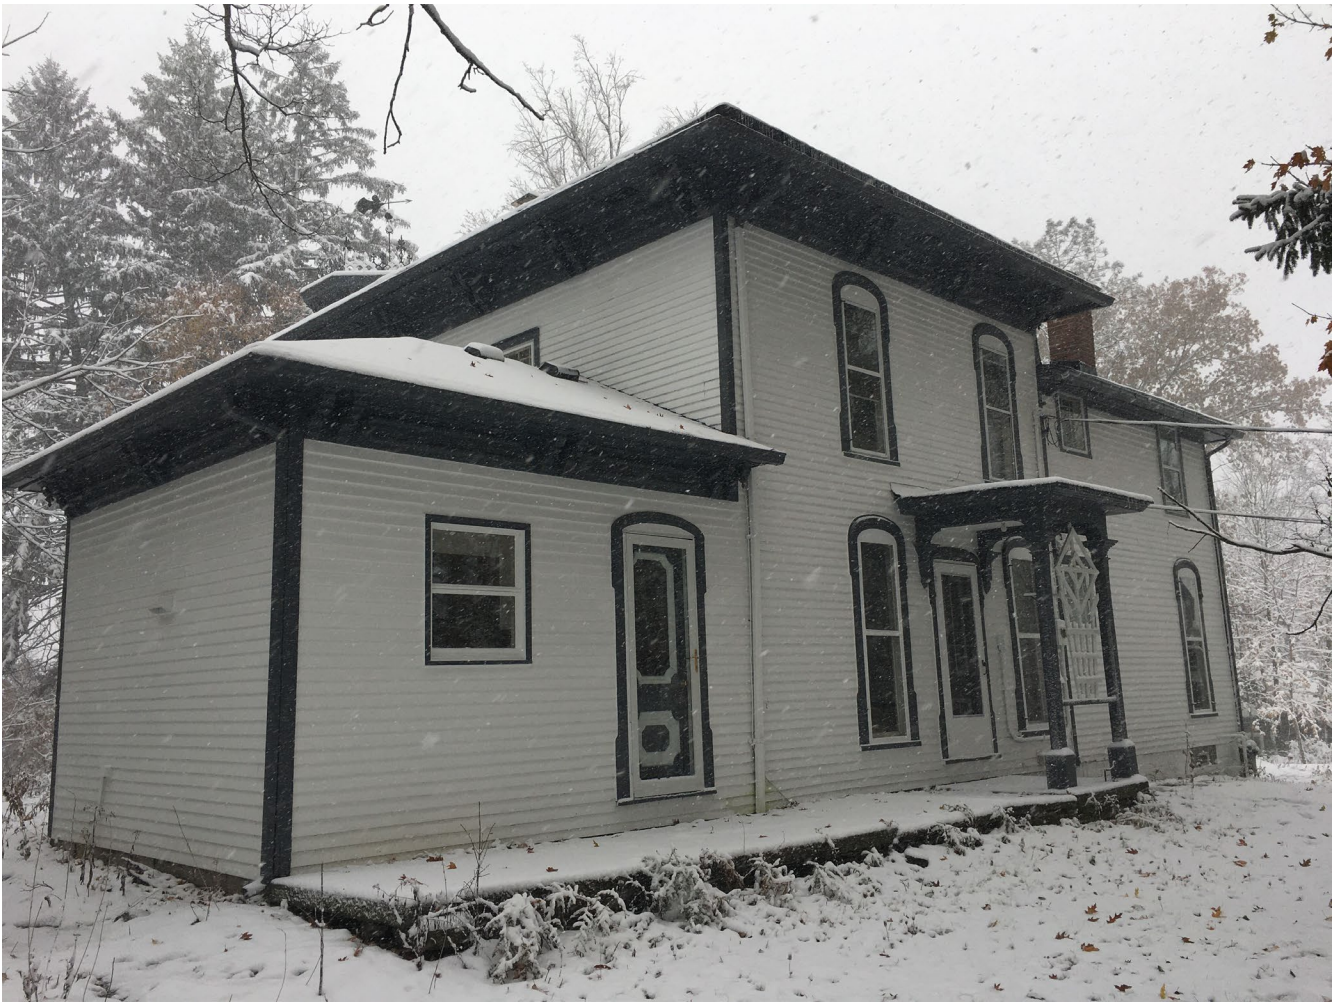
North elevation of the main house.

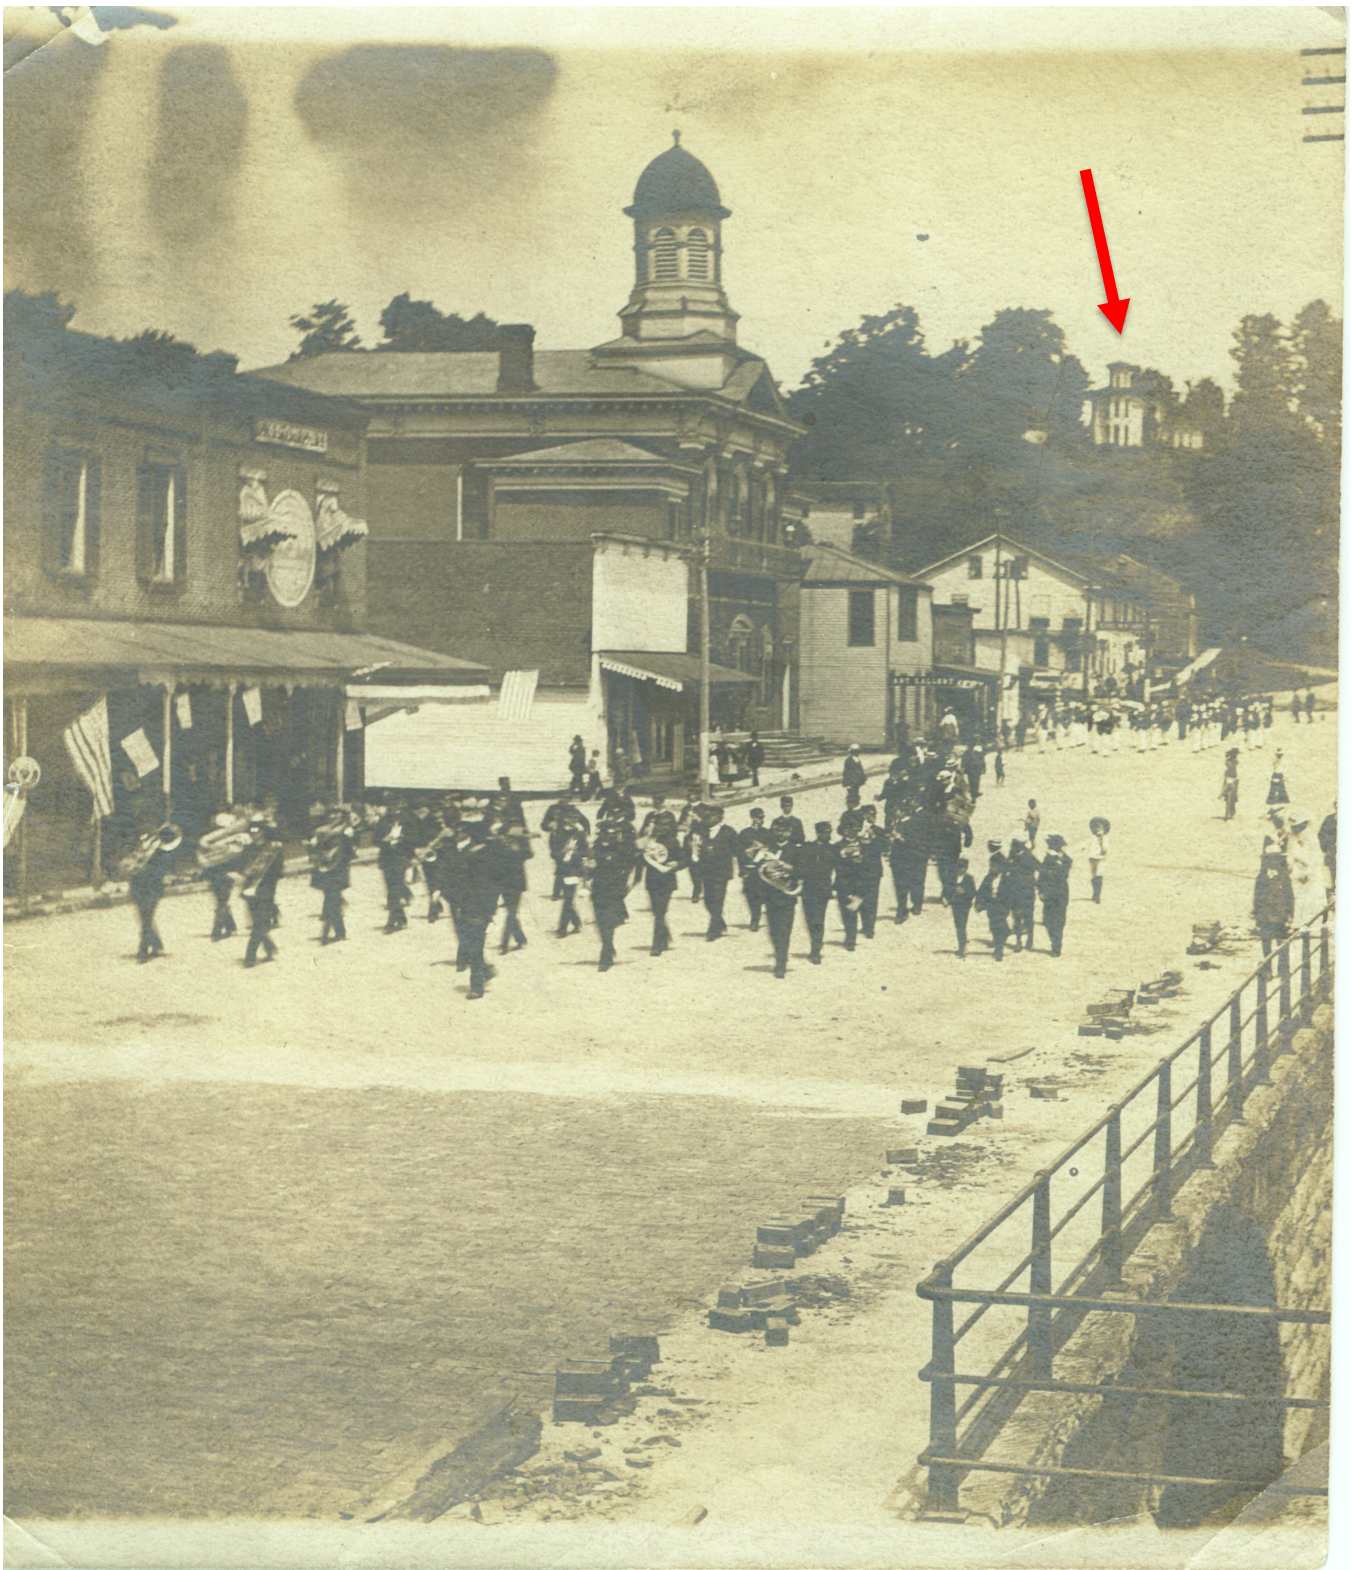
Village of Chagrin Falls c.1902, looking north towards 3 West Summit Street, visible on the hill. The addition to the west is not built. Courtesy of the Chagrin Falls Historical Society.

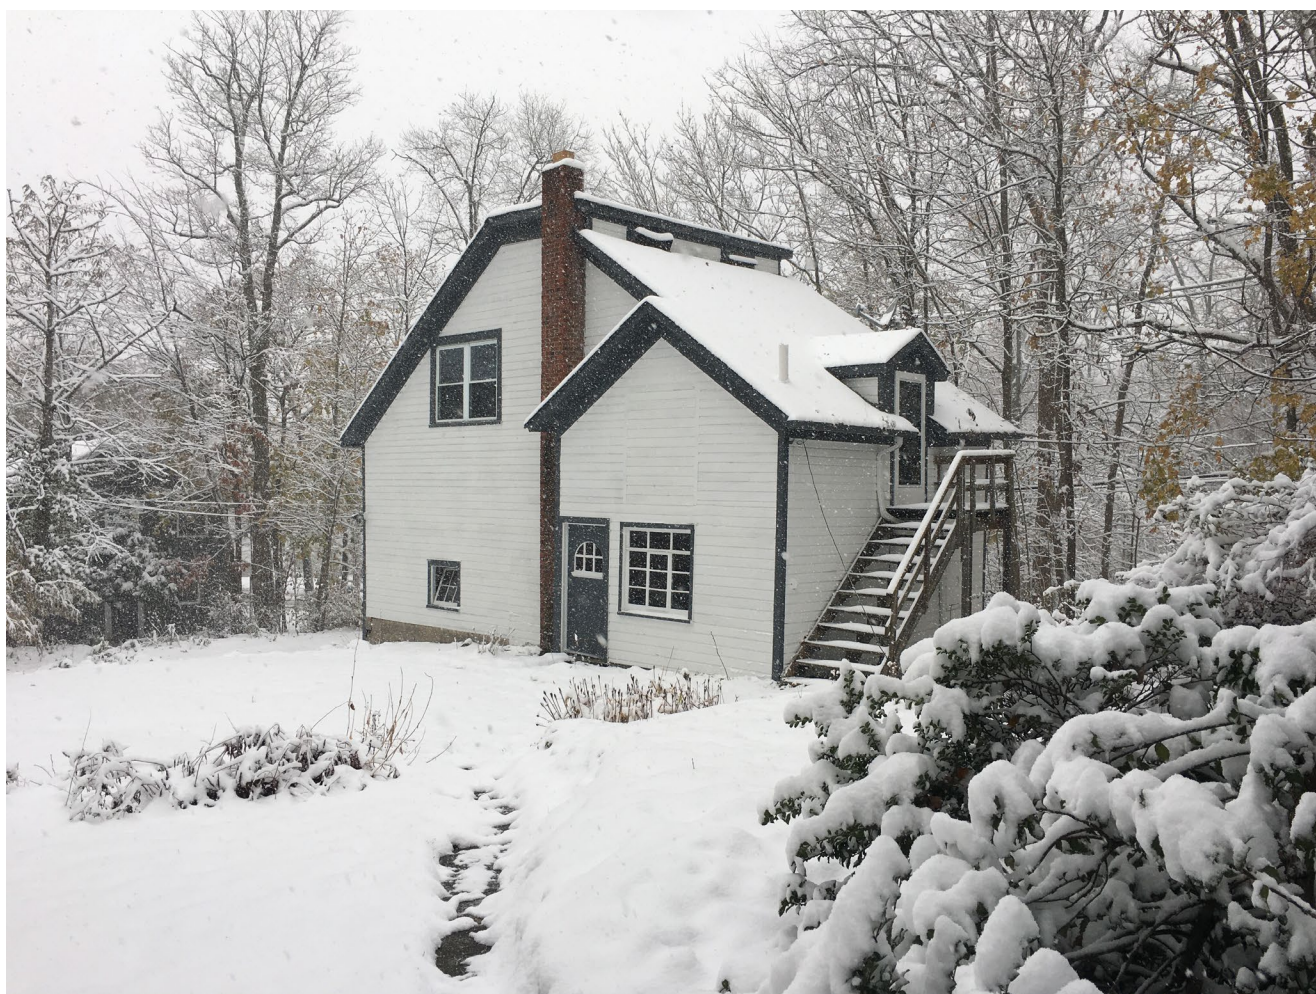
South and east elevations of the accessory building, known as the studio of artists David Philip and Binnie Wilson. It is evident that two carriage houses are merged, the one on the right dating to c1883.

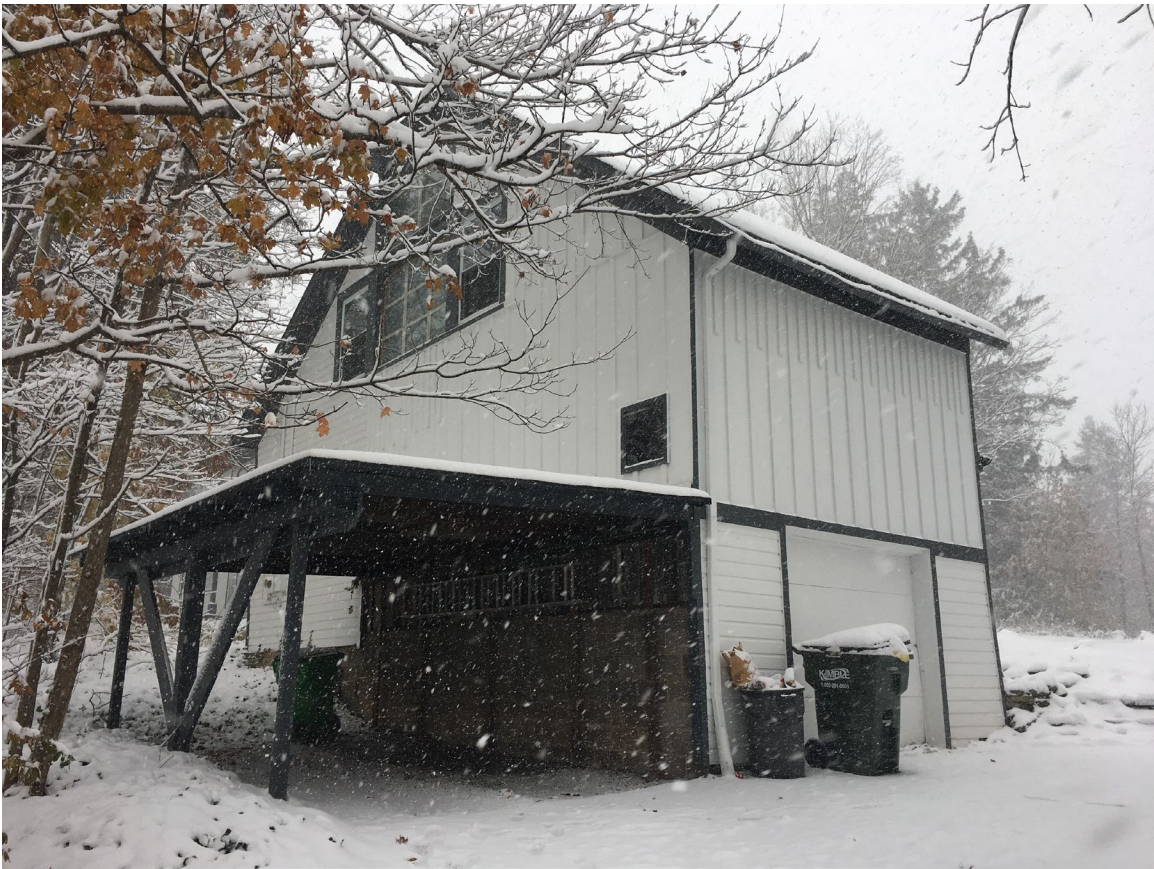
North and west elevations of the accessory building, known as the studio of artists David Philip and Binnie Wilson.

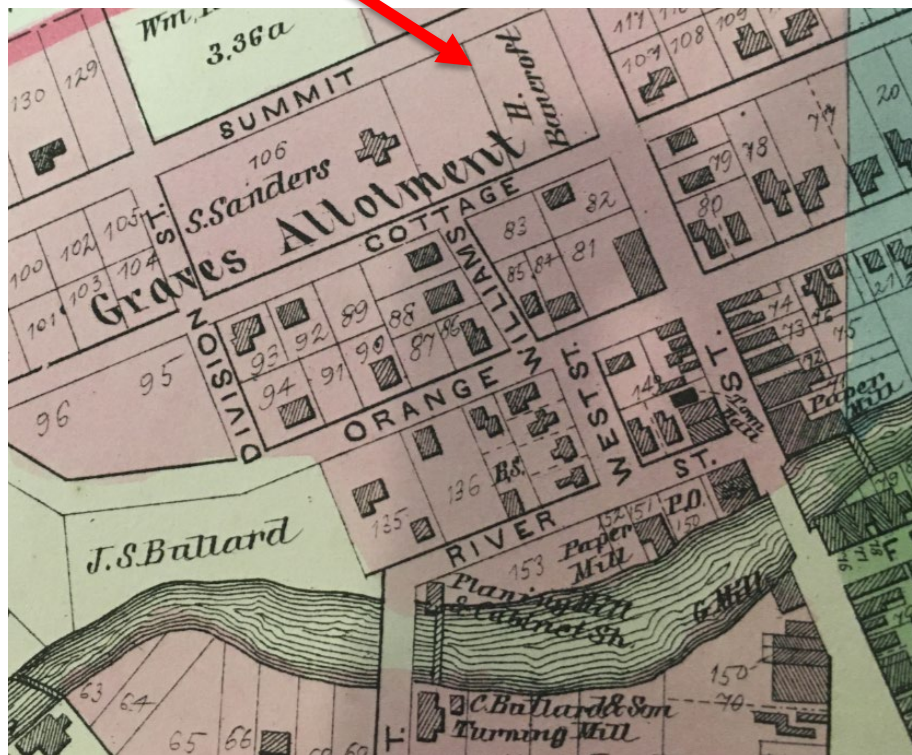
1874 Atlas published by Titus, Simmons & Titus, Courtesy of the Chagrin Falls Historical Society, showing the property is owned by H. Bancroft and no structures are on the property. 39 West Street is located to the west on the property labeled "S. Sanders."

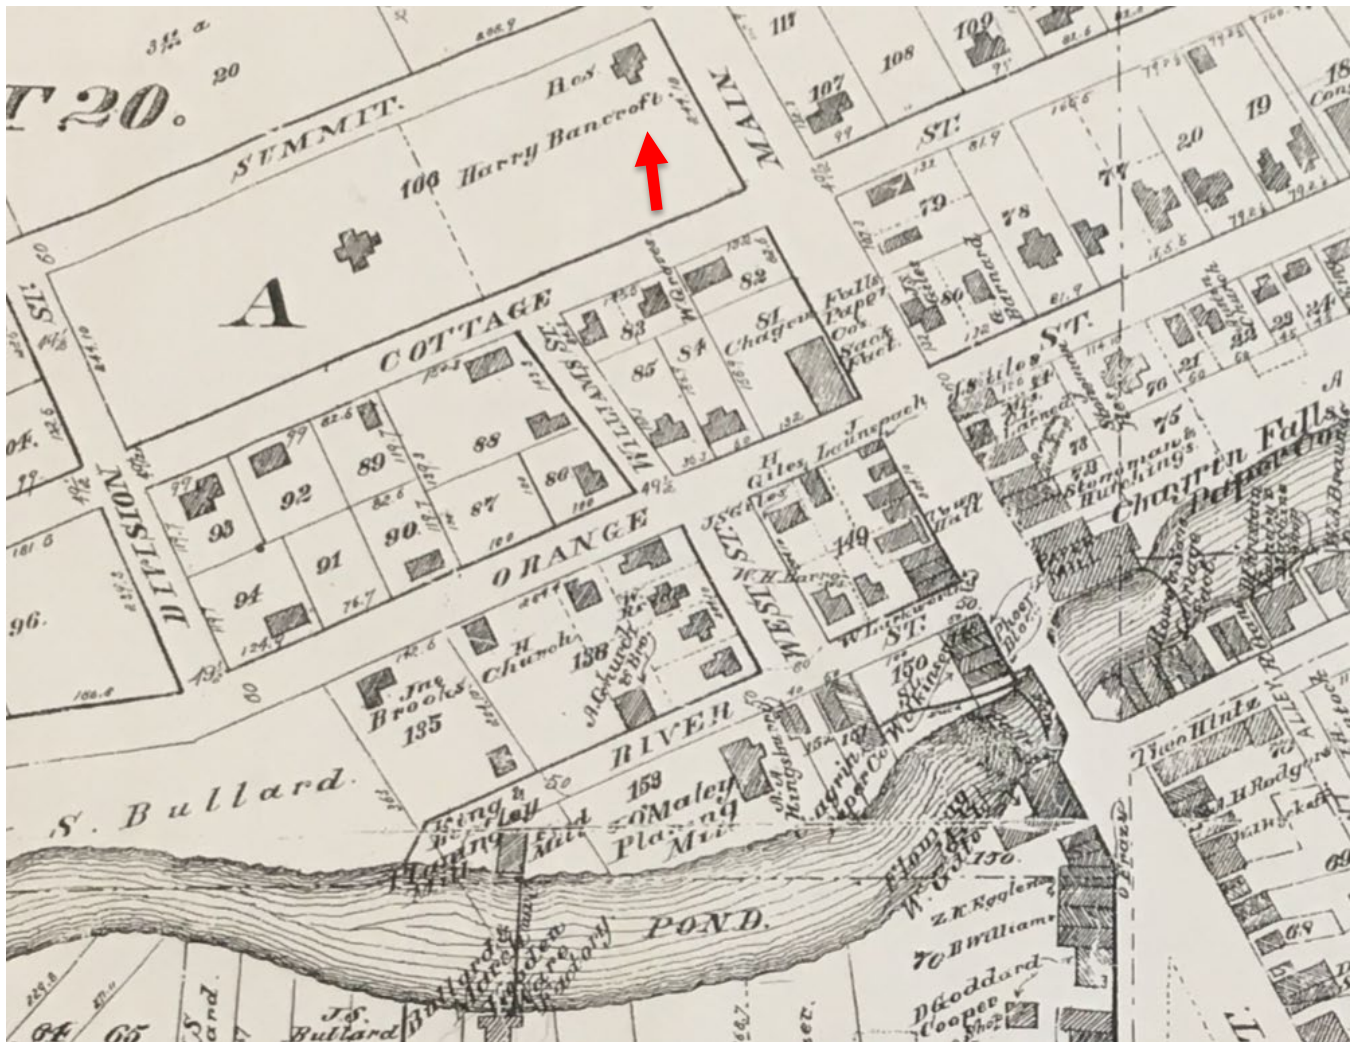
1878 Map, Courtesy of the Chagrin Falls Historical Society, showing the footprint of the main house, and the property is owned by Harry Bancroft.

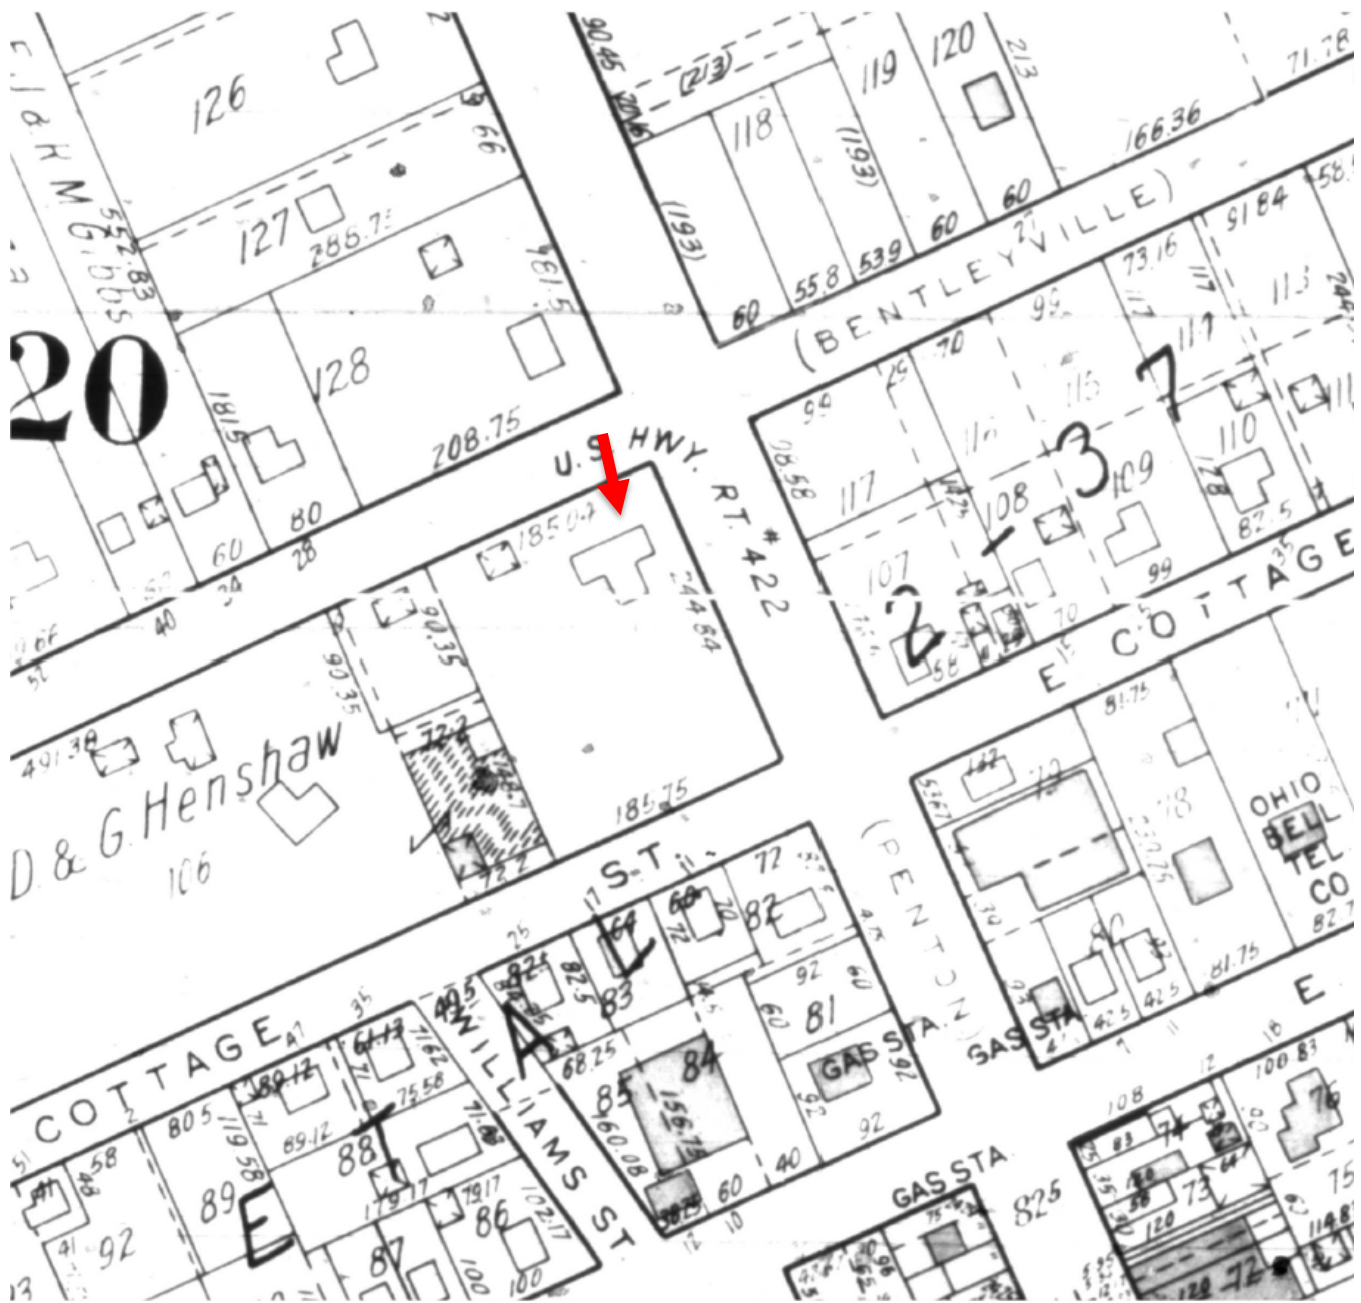
GM Hopkins Plat Book of Cuyahoga County, Vol. 3, 1950, plate 29.
 There are two accessory buildings shown to the left (west) of the main house,
 because by this time the Wilsons had combined two of the structures.

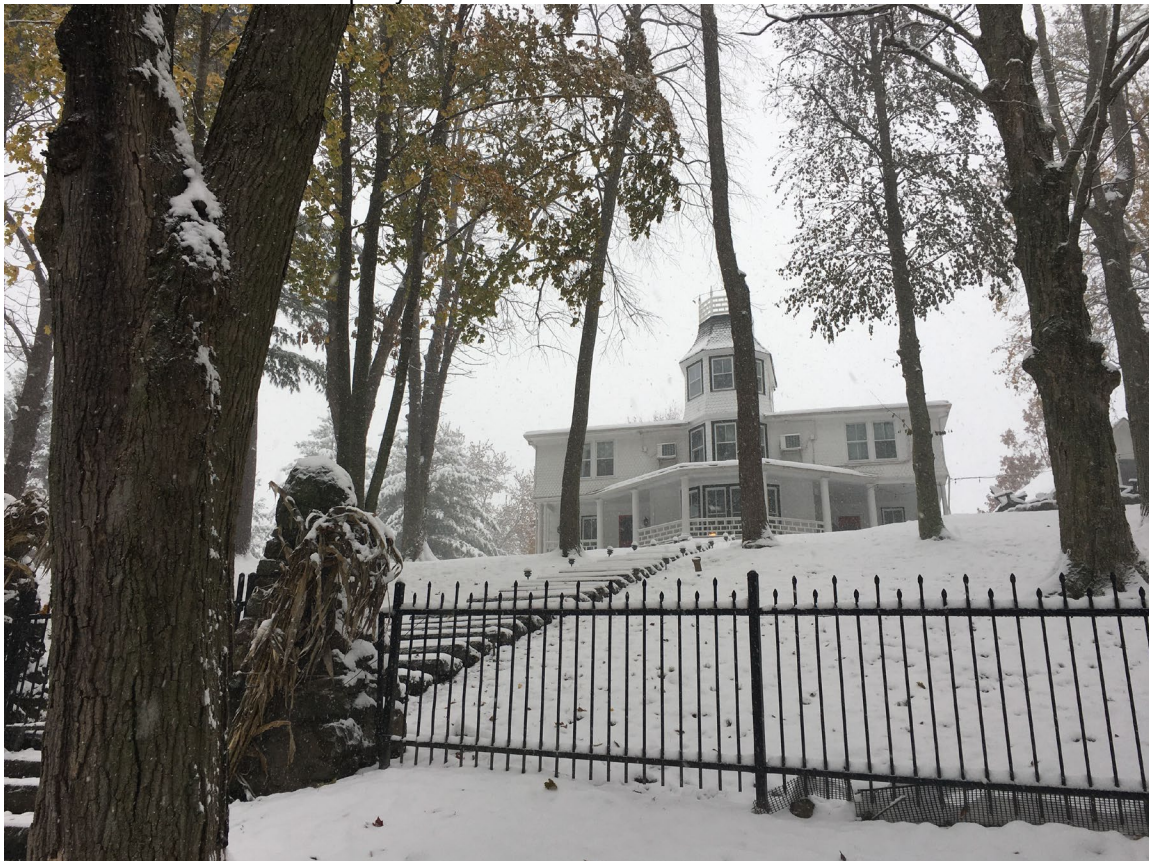
- Historic context of the block is still legible: the house at 39 West Summit Street to the west has a similar protruding multi-story bay and cupola on the south elevation. According to historic maps, it was constructed before 3 West Summit Street.

39 West Summit Street, two buildings to the west of 3 West Summit Street.
