Your Inspection Report

3 W. Summit St.
Chagrin Falls, OH 44022

INSPECTION DATE:
Friday, August 16, 2019

RE: Report No. 1972
3 W. Summit St.
Chagrin Falls, OH
44022

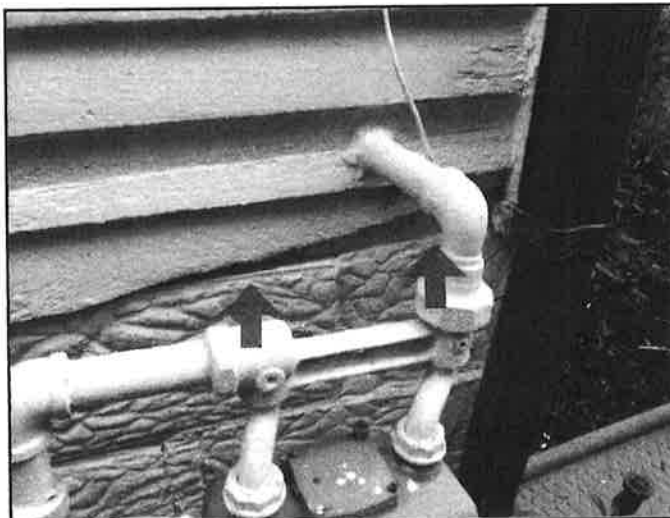
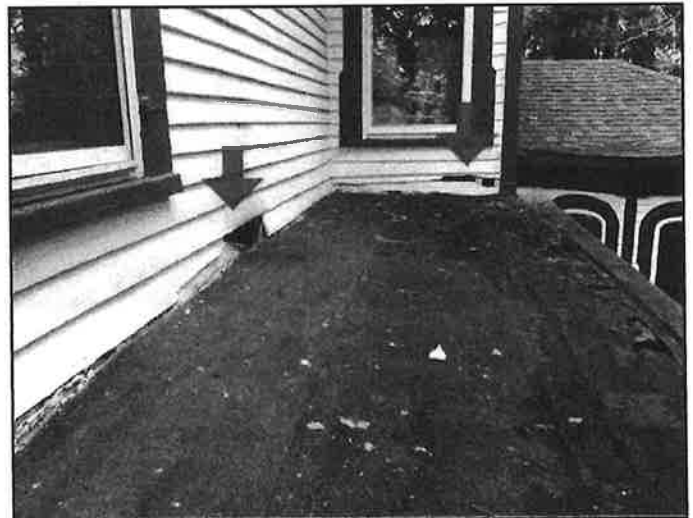
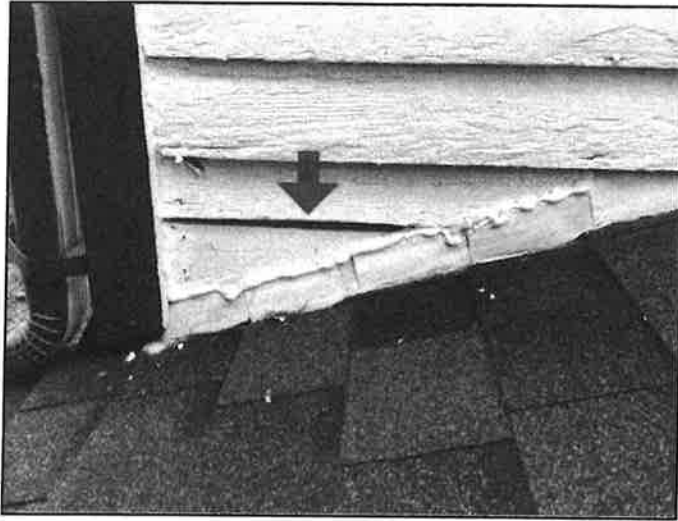
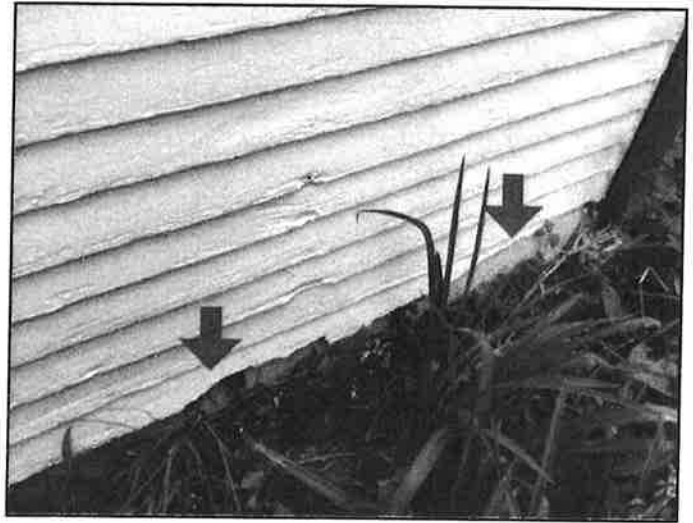
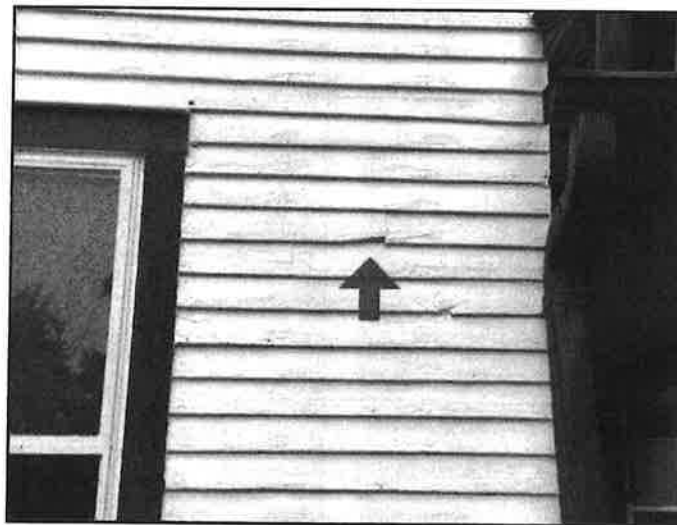
Condition: • Cracked, split or broken

Multiple boards damaged throughout exterior. Appears animals may be entering large hole in siding above porch.

Implication(s): Chance of water damage to contents, finishes and/or structure

Task: Replace

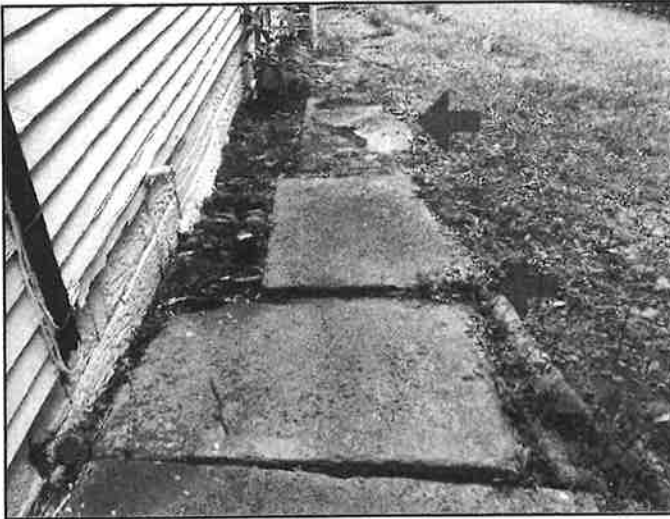
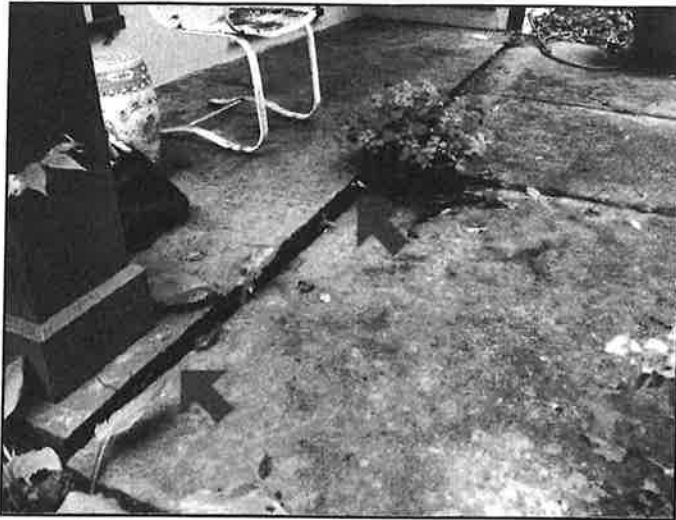
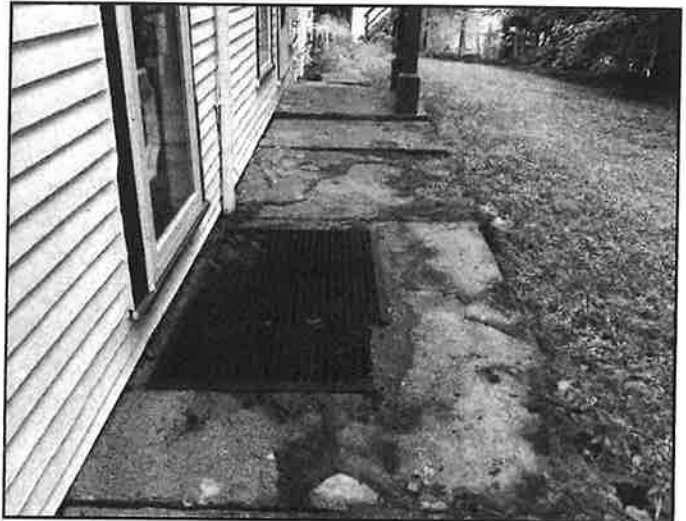
Condition: • Uneven (trip hazard)

Multiple stone walkways and patios around home in poor condition. Porch foundations have deteriorated / missing masonry. Walkways uneven / slippery. Walkway from garage has multiple loose stones and stair rise / run improper.

Task: Repair or replace

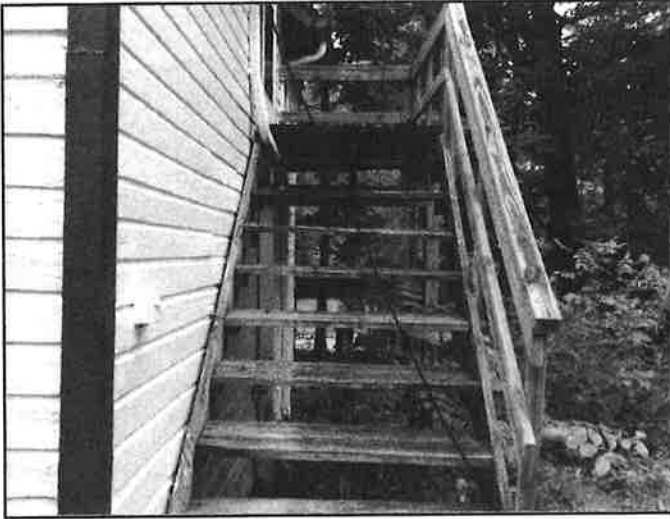
Condition: • Garage / guest house in poor condition. Whole building is racked toward street. Multiple large cracks through foundation. Wood siding / trim damaged and missing in places. Flat roof is sagged toward middle. Visible wiring in need of corrections.

Implication(s): Further Deterioration / Structural Collapse

Task: Repair / Replace

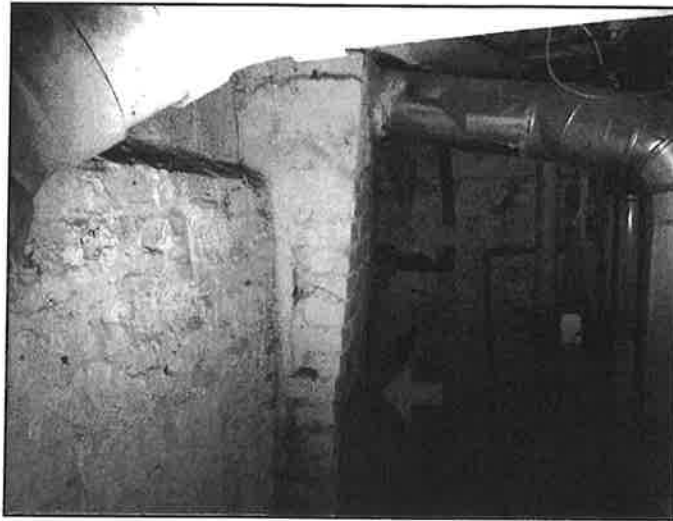
39. Bowed, bulging or leaning

Condition: • Bowed, bulging or leaning

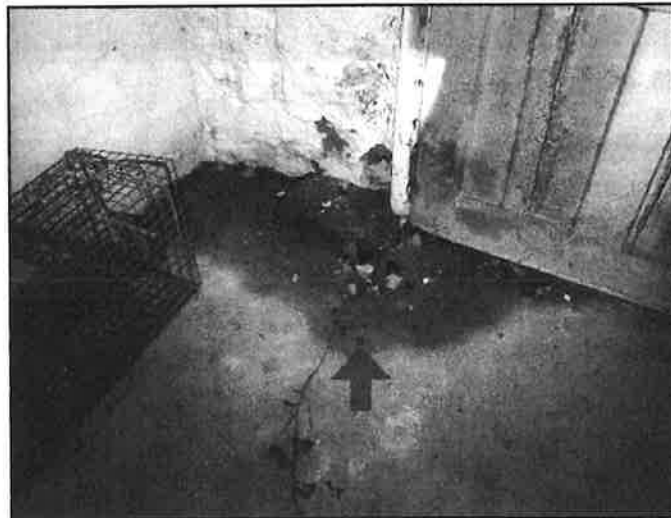
Condition: • Dampness on floor or walls

Implication(s): Chance of water damage to contents, finishes and/or structure | Material deterioration

69. Water Stains

70. Dampness on floor or walls

71. Dampness on floor or walls

Task: Further evaluation

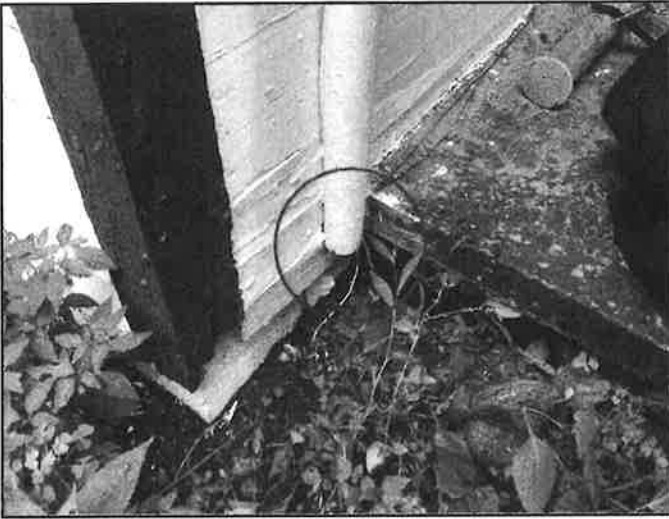
95. Discharge too close to building

8. Condition: • Discharge too close to building

Implication(s): Chance of water damage to contents, finishes and/or structure

Task: Correct

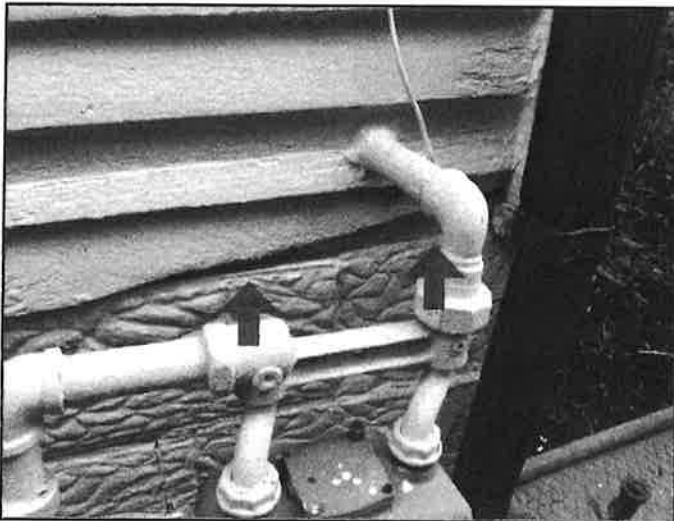
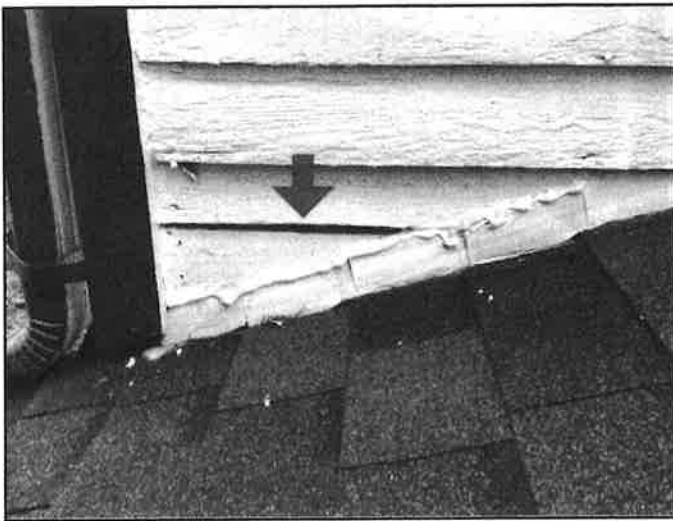
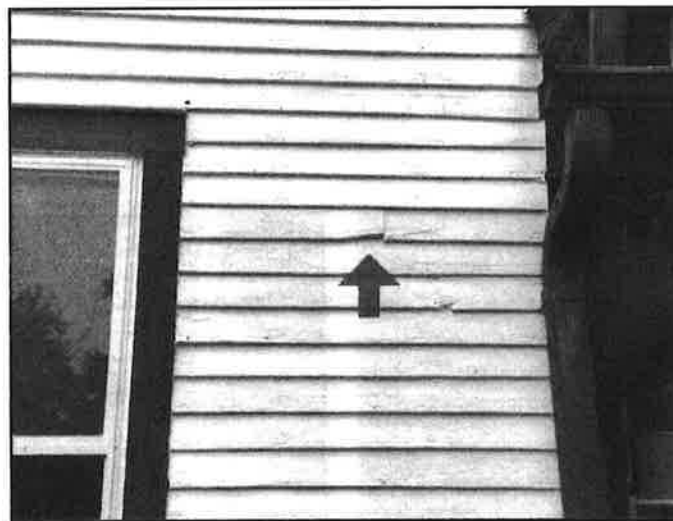
13. **Condition:** • Cracked, split or broken

Multiple boards damaged throughout exterior. Appears animals may be entering large hole in siding above porch.

Implication(s): Chance of water damage to contents, finishes and/or structure

Task: Replace

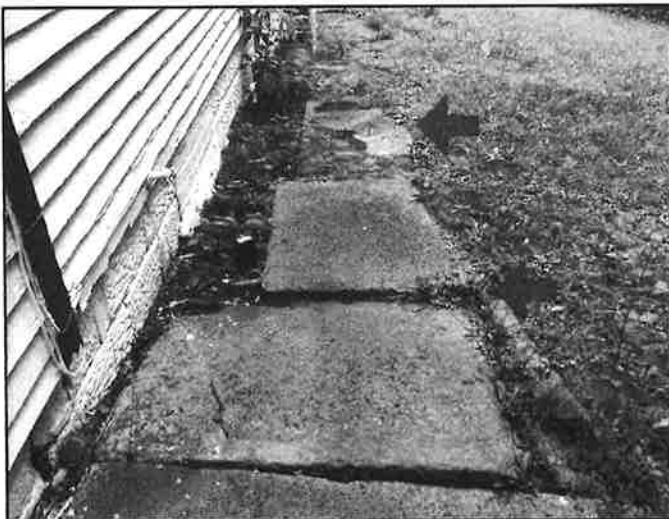
Multiple stone walkways and patios around home in poor condition. Porch foundations have deteriorated / missing masonry. Walkways uneven / slippery. Walkway from garage has multiple loose stones and stair rise / run improper.

127. Uneven (trip hazard)

Task: Repair or replace

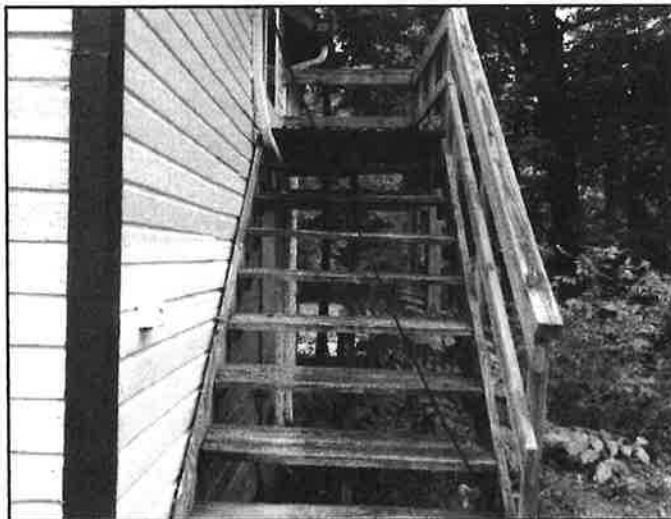
22. Condition: • Garage / guest house in poor condition. Whole building is racked toward street. Multiple large cracks through foundation. Wood siding / trim damaged and missing in places. Flat roof is sagged toward middle. Visible wiring in need of corrections.

135. Loose Steps / Rot

Task: Repair / Replace

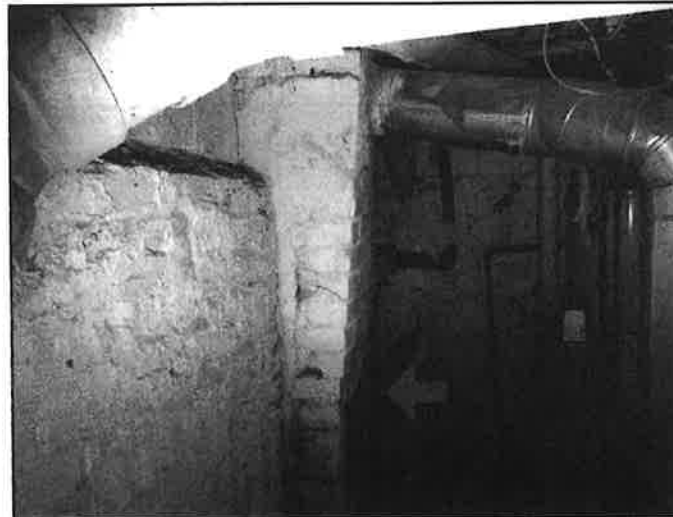
25. Condition: • Bowed, bulging or leaning

151. Bowed, bulging or leaning

Task: Further Evaluation

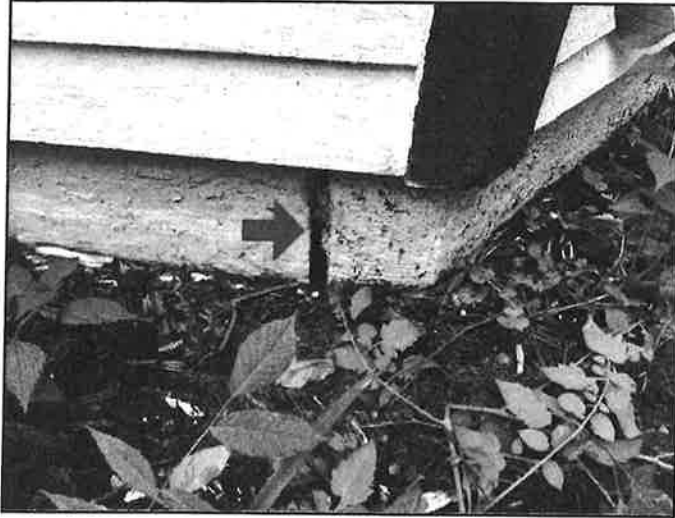
26. Condition: • Mortar deteriorated or missing

152. Mortar deteriorated or missing

Task: Repair
