Your Inspection Report

3 W. Summit St.
Chagrin Falls, OH 44022

INSPECTION DATE:
Friday, August 16, 2019

RE: Report No. 1972
3 W. Summit St.
Chagrin Falls, OH
44022

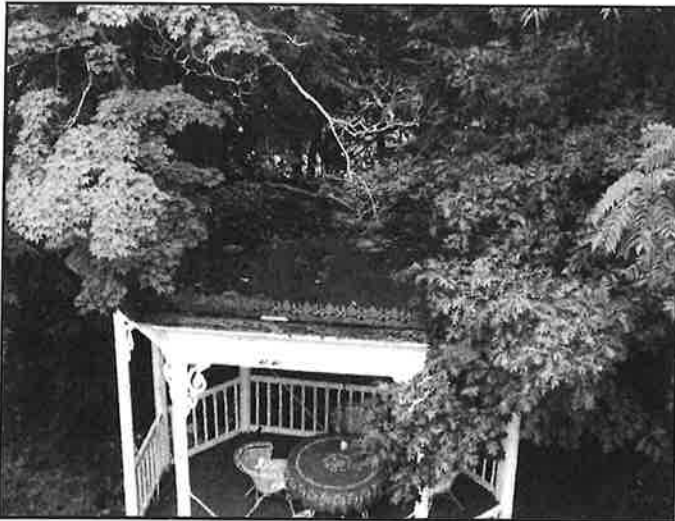
1. Debris / Worn

Condition: • Flat roofs around house in poor condition. Holes / rot noted on front porch. Poorly flashed and missing / worn out materials on others.

Implication(s): Water Damage to Contents / Structure

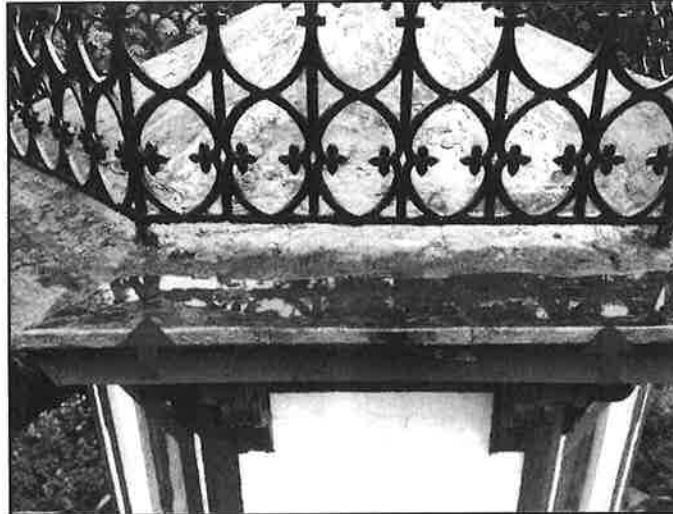
5. Metal

Condition: • Older metal roofing on widows walk rusted and ponding.

Implication(s): Water Damage to Contents

Task: Correct

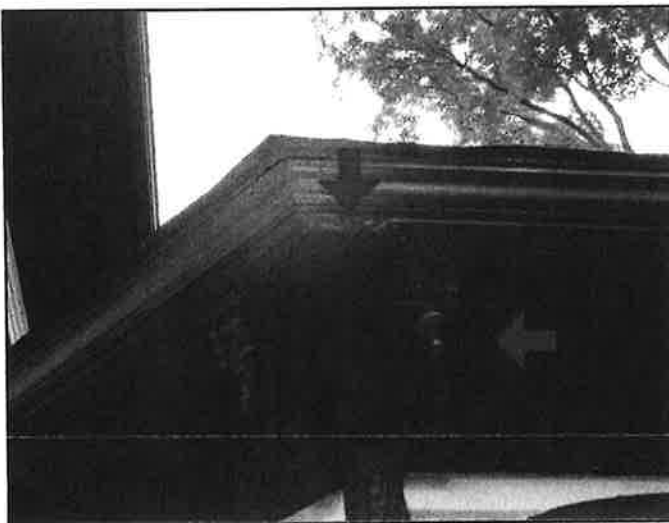
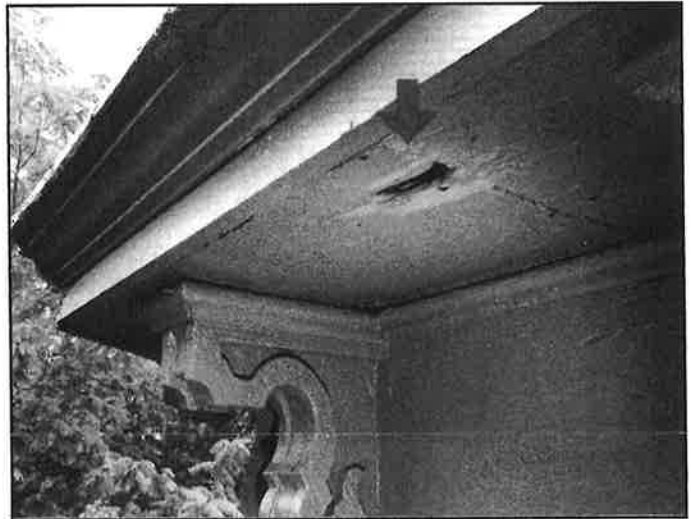
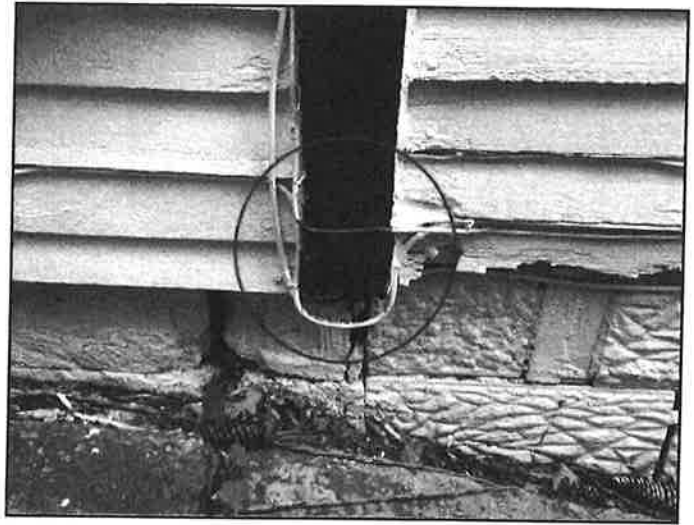
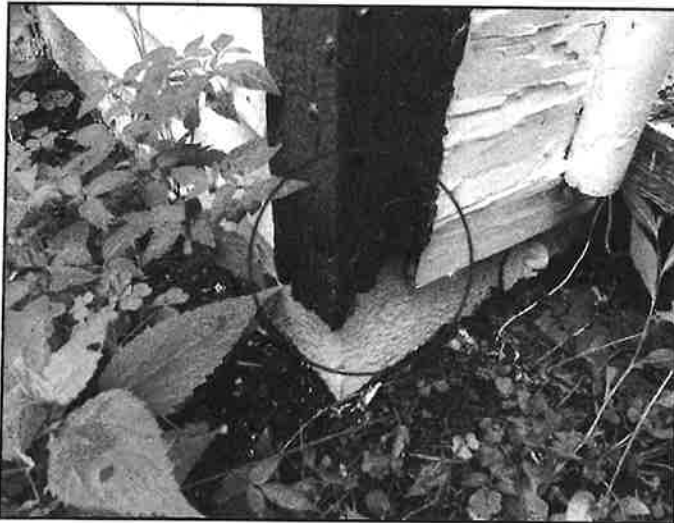
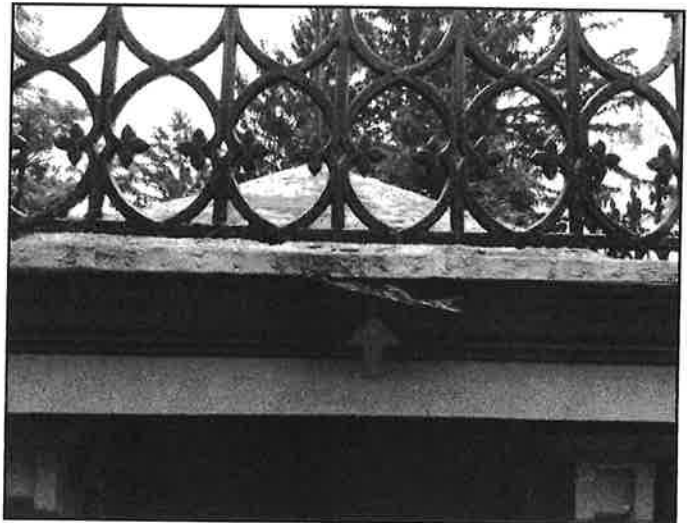
Condition: • Rot

Multiple areas around home with rot noted on trim. Severe rot to soffit / trim of widows walk.

Implication(s): Chance of water damage to contents, finishes and/or structure | Material deterioration

Task: Replace

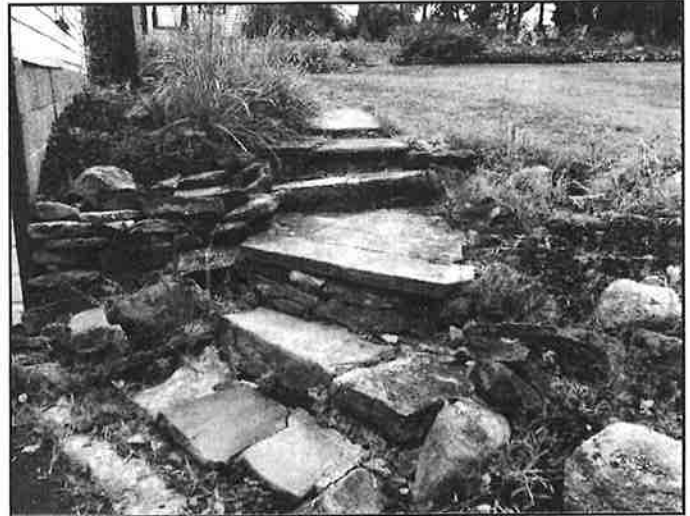
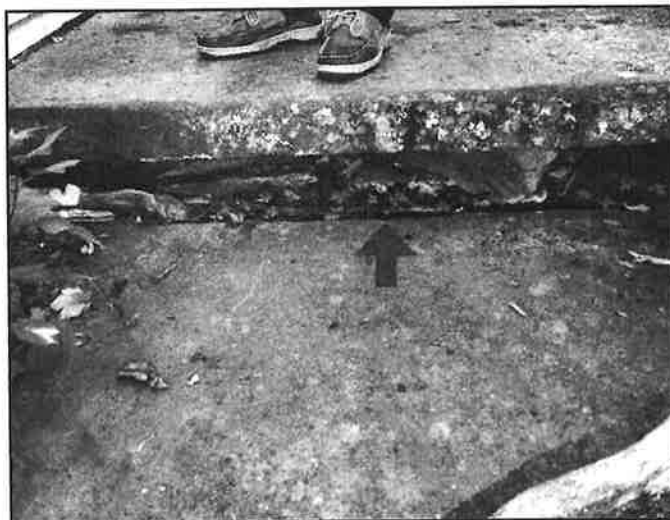
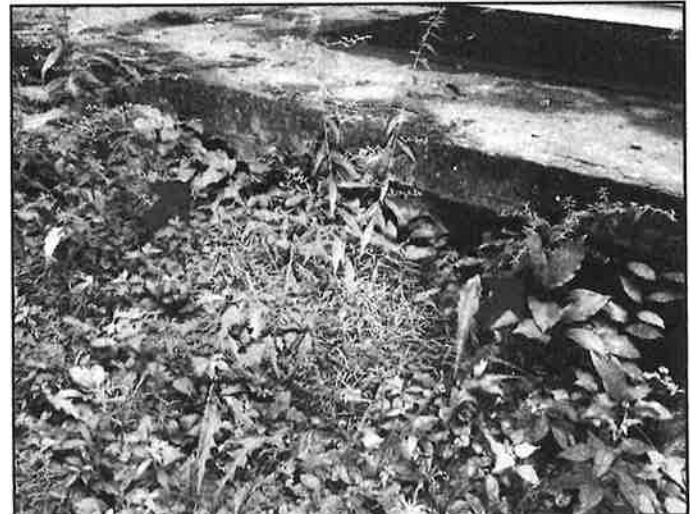
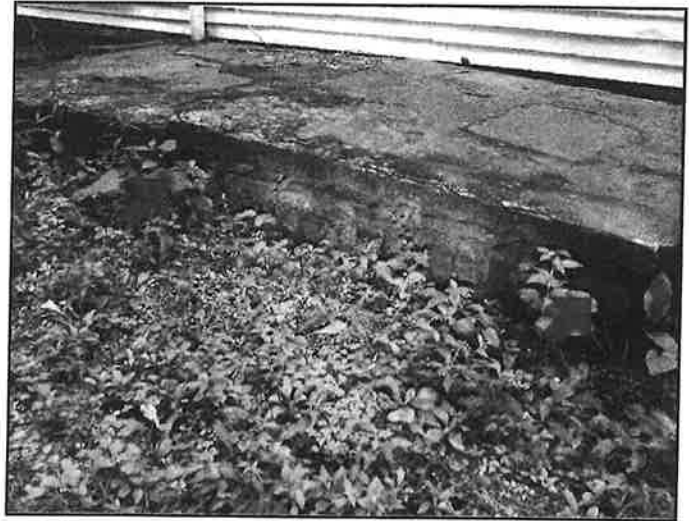
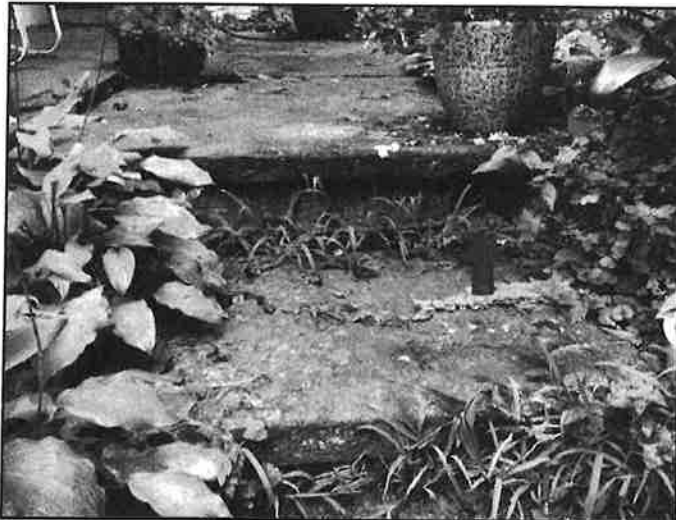
Condition: • Uneven (trip hazard)

Multiple stone walkways and patios around home in poor condition. Porch foundations have deteriorated / missing masonry. Walkways uneven / slippery. Walkway from garage has multiple loose stones and stair rise / run improper.

Task: Repair or replace

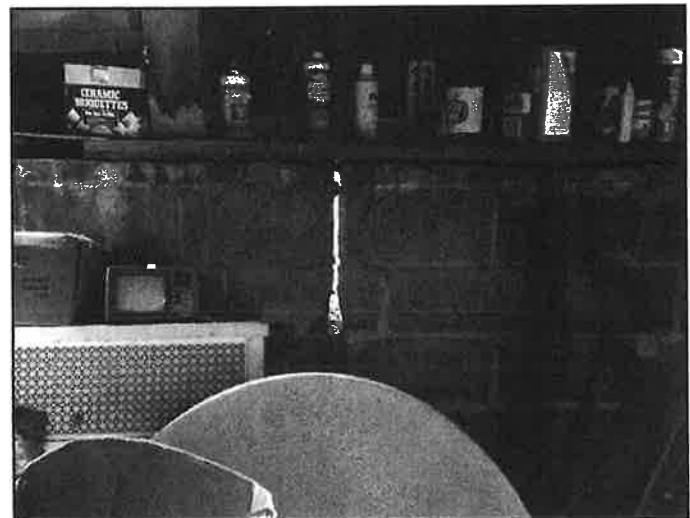
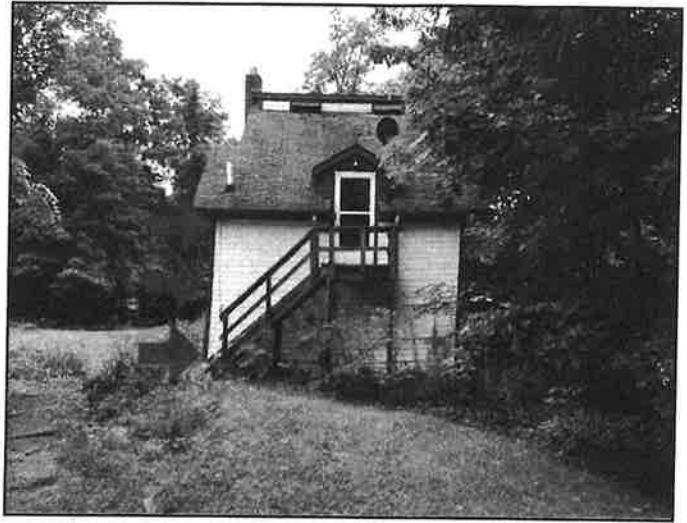
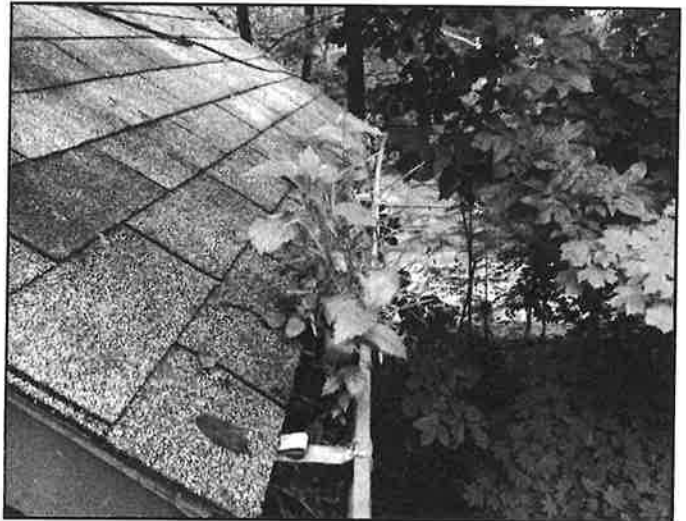
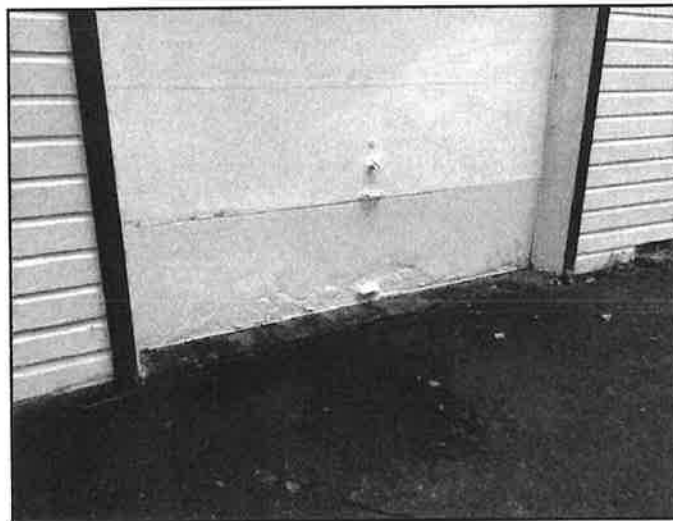
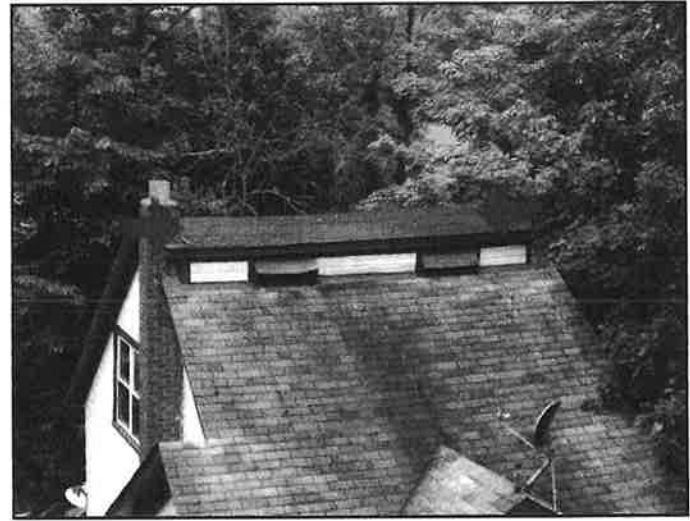
Condition: • Garage / guest house in poor condition. Whole building is racked toward street. Multiple large cracks through foundation. Wood siding / trim damaged and missing in places. Flat roof is sagged toward middle. Visible wiring in need of corrections.

Implication(s): Further Deterioration / Structural Collapse

Task: Repair / Replace

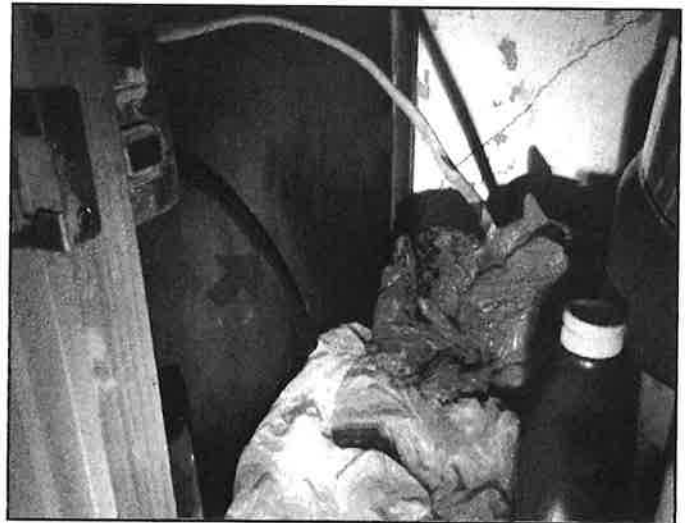
Condition: • Exposed on walls or ceilings

45. Exposed

46. Exposed

Task: Correct

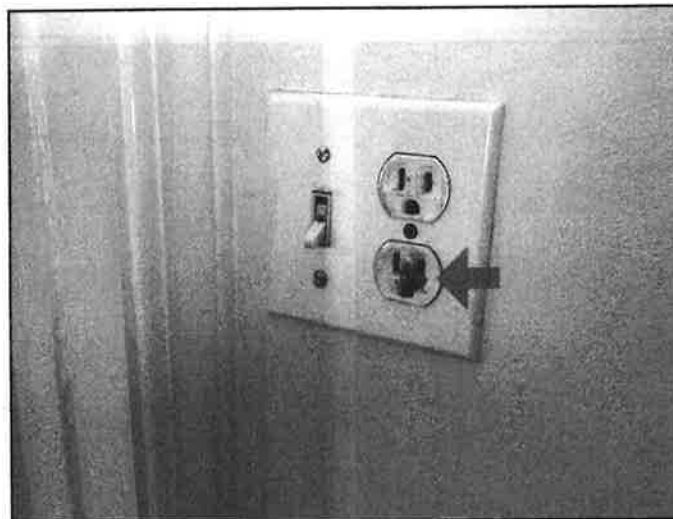
DISTRIBUTION SYSTEM \ Outlets (receptacles)**Condition:** • Damage

Outlet scorched.

Implication(s): Electric shock | Fire hazard**Location:** First Floor Hall**Task:** Replace

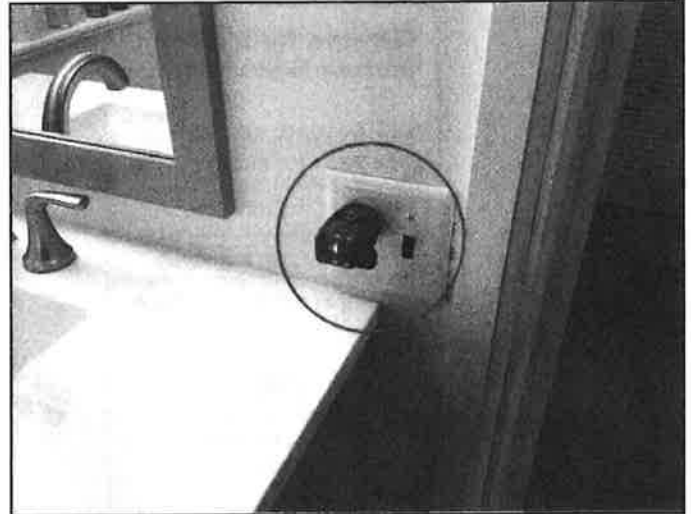
*47. Damage***Condition:** • GFCI/GFI needed (Ground Fault Circuit Interrupter)

All exterior / garage / bathroom / kitchen outlets should be GFCI protected.

48. Bath

49. Kitchen

50. Bath

51. Bath

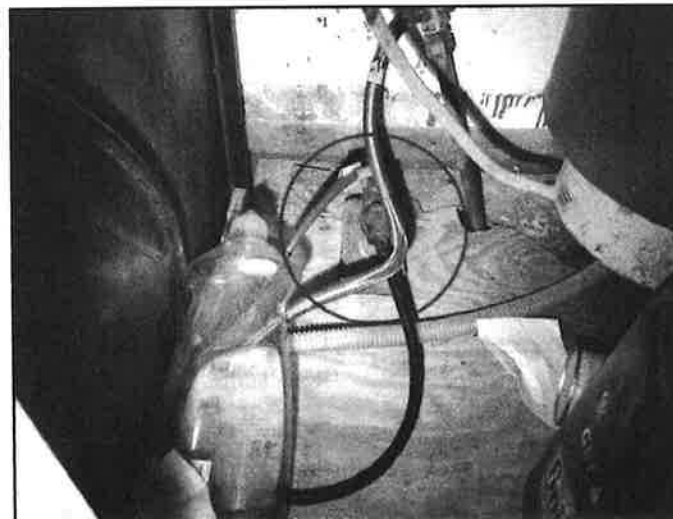
Condition: • In floors or countertops

Outlet box should not be mounted on floor of cabinet where liquids / water can enter. Recommend moving box to side of cabinet. Improper extension cord being used for dishwasher.

52. In floors

Task: Correct

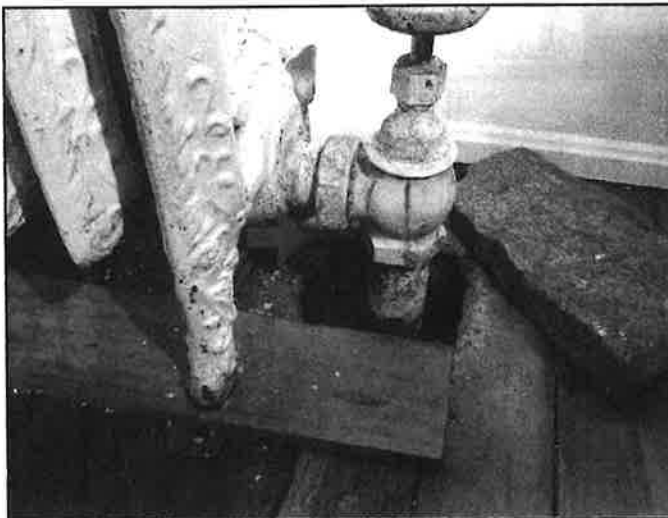
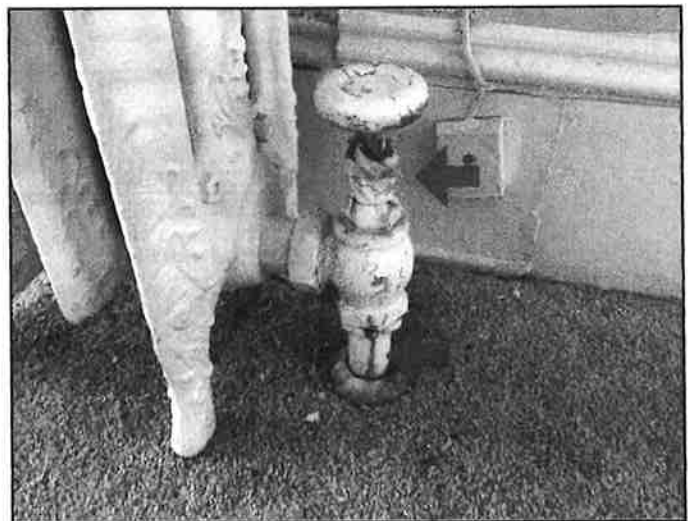
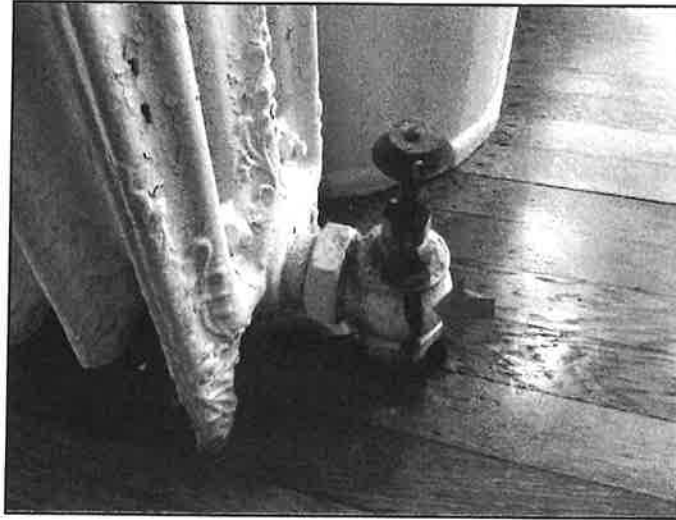
Condition: • Leak

One radiator actively leaking. Other radiators with signs of leaks.

Implication(s): Chance of water damage to contents, finishes and/or structure

56. Leaking

57. Stained

58. Stained

Task: Repair

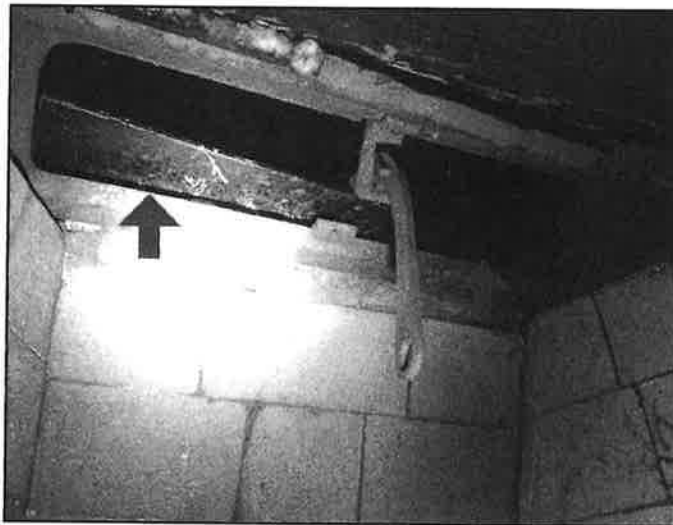
Condition: • Inoperative

Implication(s): Hazardous combustion products entering home

59. Inoperative

Task: Correct

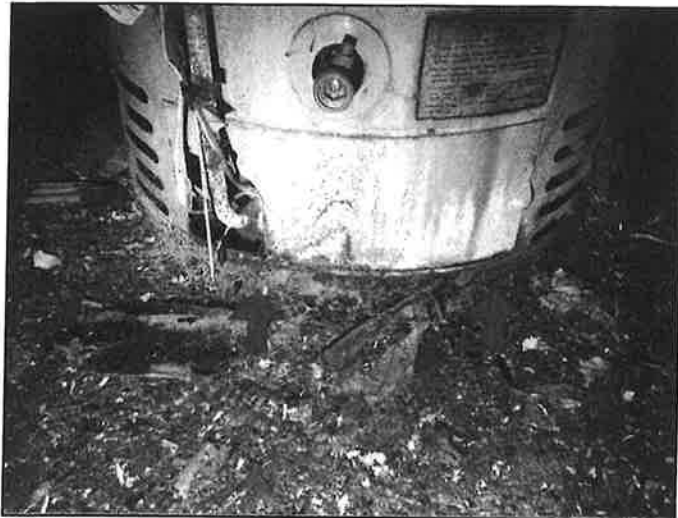
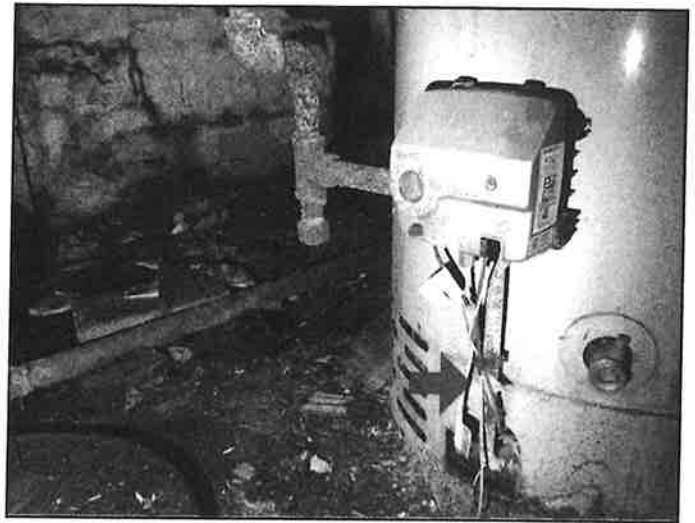
Implication(s): Equipment not operating properly | Fire or explosion**Location:** Rear Garage**Task:** Correct**WATER HEATER \ Tank****Condition:** • Rust

Water tank in poor condition for age. Rust noted throughout tank, gas line and vent pipe.

Implication(s): System inoperative | No hot water**Location:** Basement**Task:** Monitor

60. Rust

61. Rust

62. Rust

63. Rust

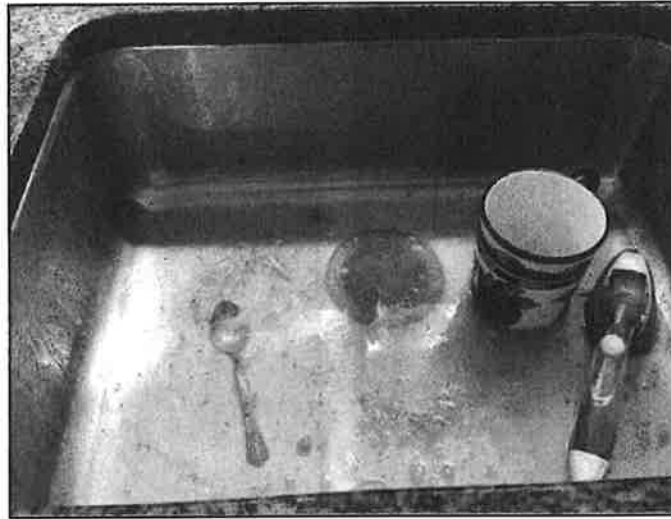
Condition: • Slow drains

Implication(s): Chance of water damage to contents, finishes and/or structure

65. Slow drains

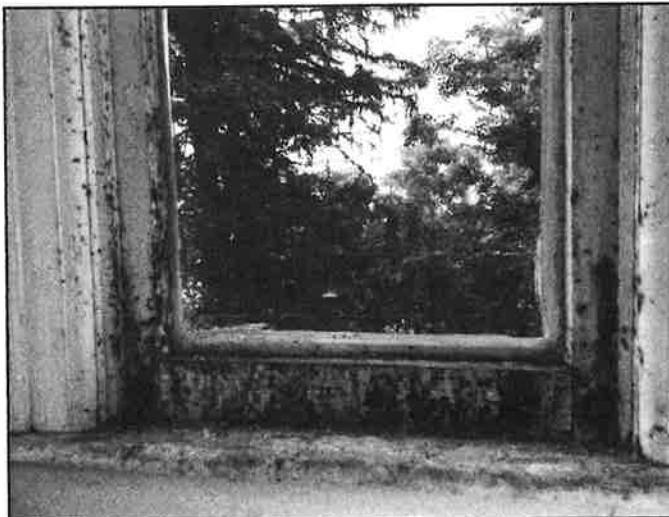
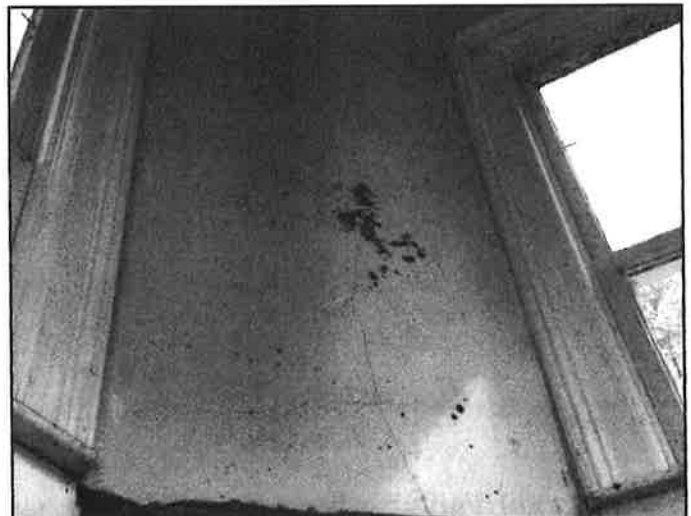
Condition: • Possible mold

Probable mold noted inside widows walk.

Implication(s): Health Hazard

66. Possible mold

67. Possible mold

Task: Further evaluation / Remediation

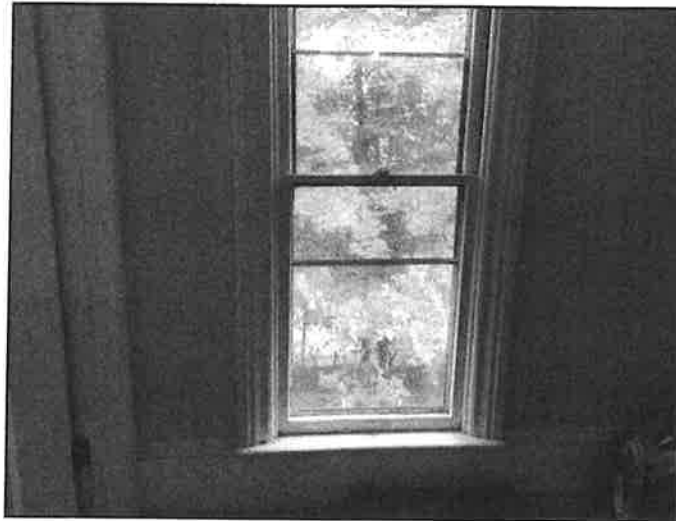
Condition: • Original lower quality units

Older original units in overall poor condition. Multiple windows inoperable. Various windows with cracked glass.

68. Inoperable

Task: Improve

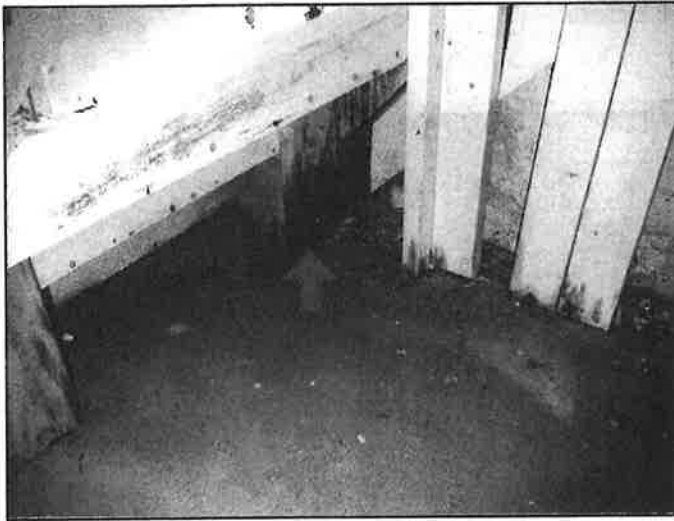
Condition: • Dampness on floor or walls

Implication(s): Chance of water damage to contents, finishes and/or structure | Material deterioration

69. Water Stains

70. Dampness on floor or walls

71. Dampness on floor or walls

Task: Further evaluation

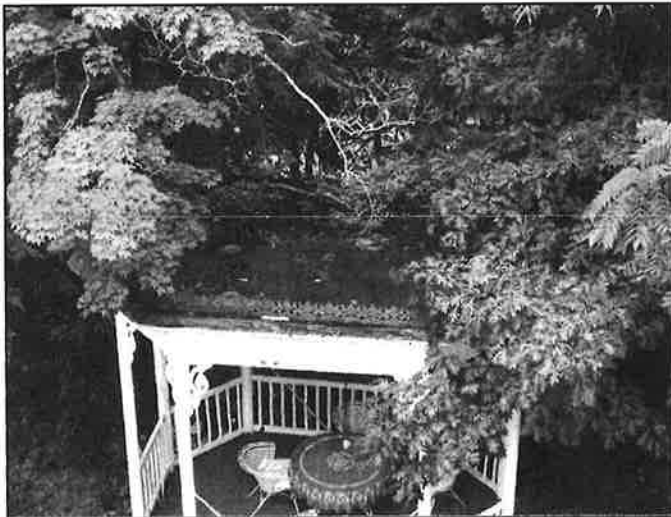
81. Debris / Worn

2. Condition: • Flat roofs around house in poor condition. Holes / rot noted on front porch. Poorly flashed and missing / worn out materials on others.

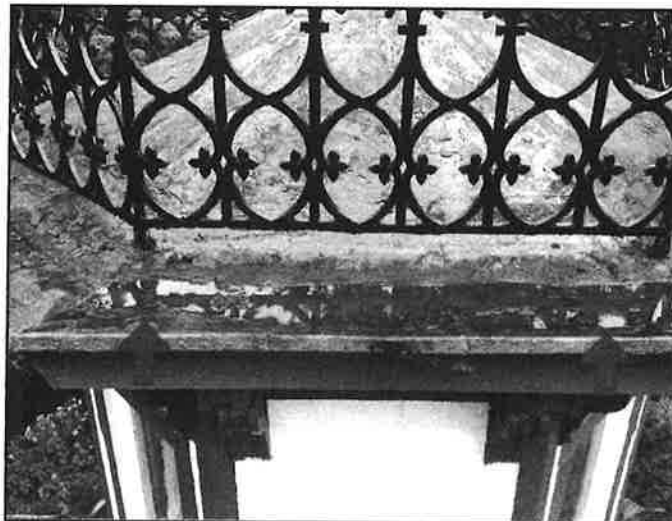
85. Metal

3. Condition: • Older metal roofing on widows walk rusted and ponding.

Task: Correct

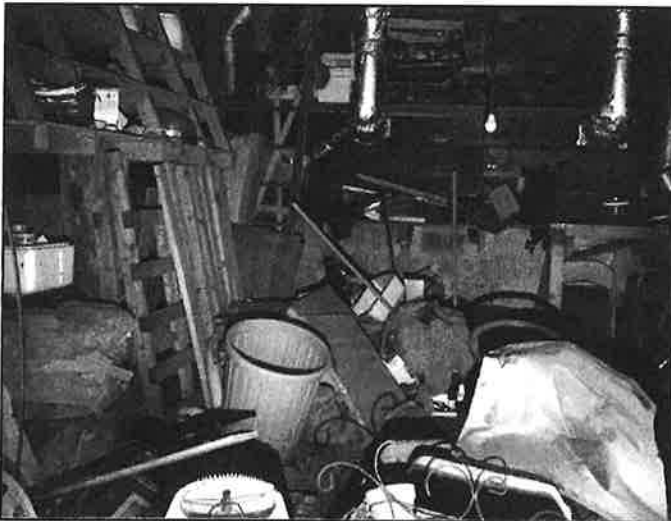
88. Storage

Unable to fully inspect interior of garage due to storage. Unable to gain access to second floor living area.

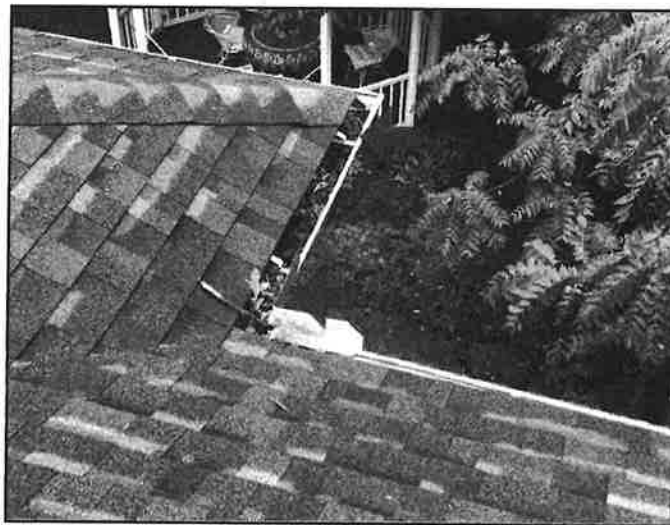
92. *Clogged*

5. **Condition:** • Clogged

Task: Clean

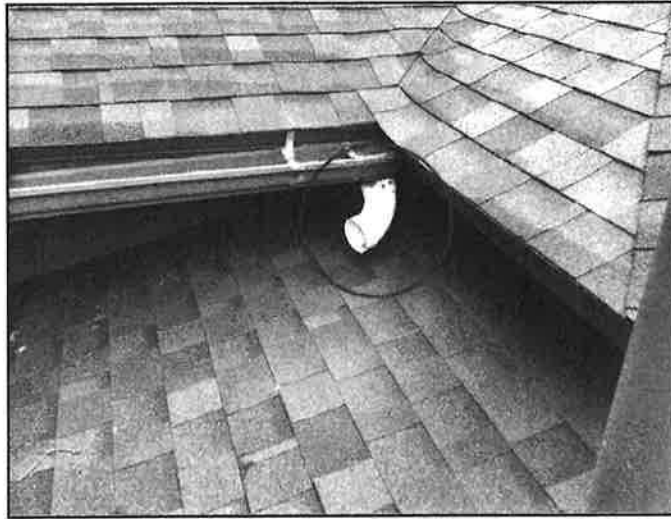
93. *Improper Materials.*

6. **Condition:** • Improper Materials.

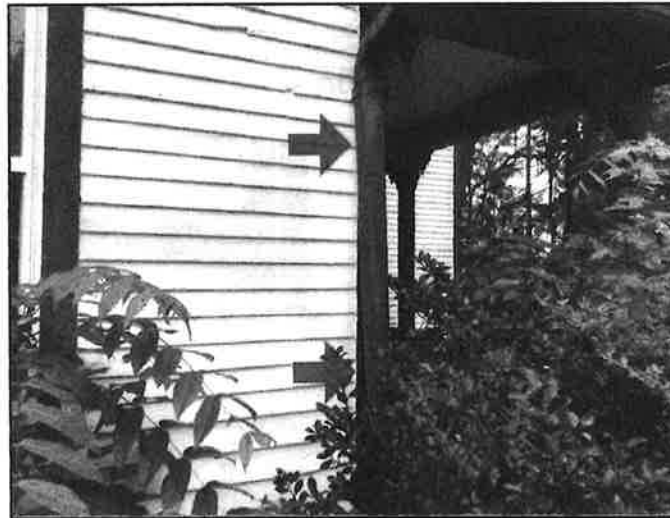
97. Loose

9. Condition: • Loose

Task: Correct

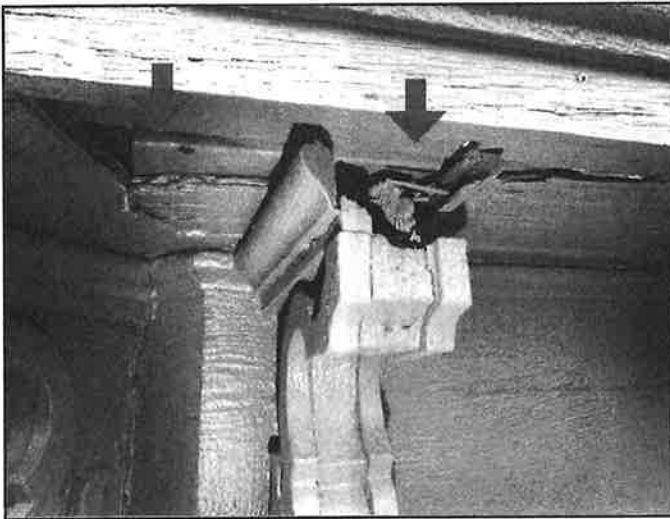
11. Condition: • Rot

Multiple areas around home with rot noted on trim. Severe rot to soffit / trim of widows walk.

Implication(s): Chance of water damage to contents, finishes and/or structure | Material deterioration

Task: Replace

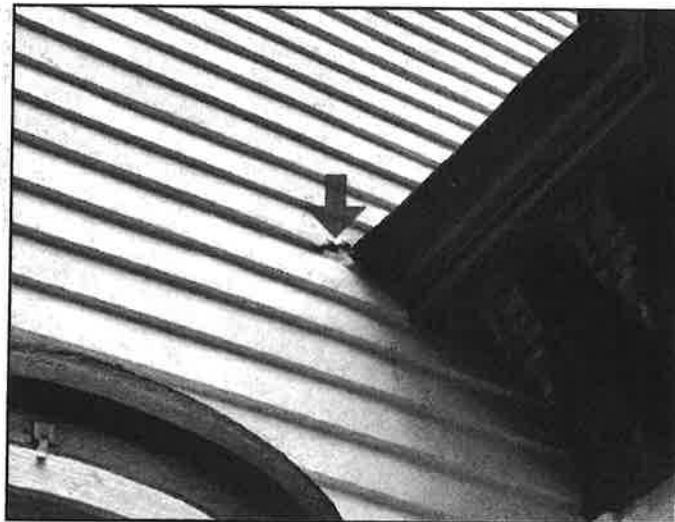
14. Condition: • Rot

Implication(s): Weakened structure | Material deterioration

Task: Replace

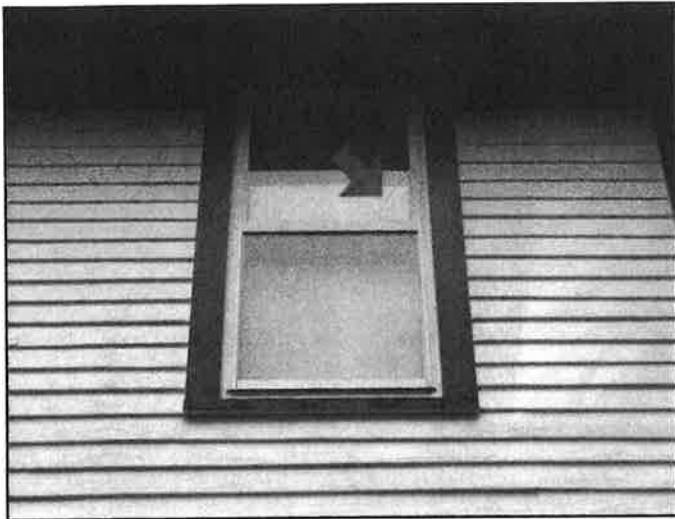
15. Condition: • Cracked

Multiple windows with cracked glass noted.

Task: Replace

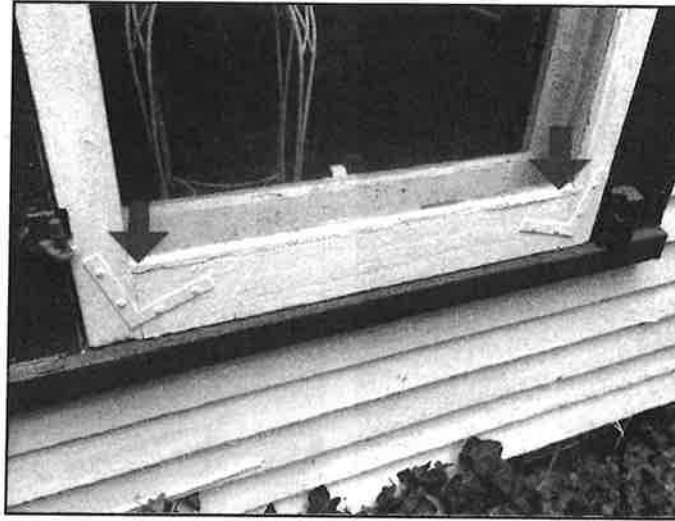
118.

16. Condition: • Previous repairs noted on storm frame.

Task: Monitor / Repair

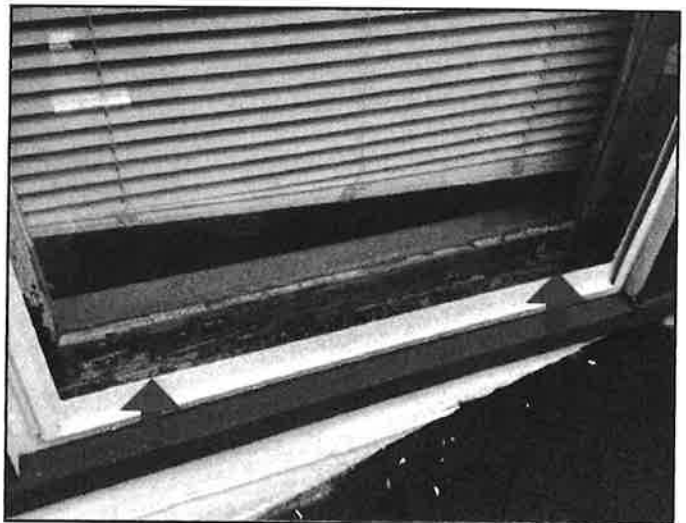
17. Condition: • Window frames and sills all in need of paint.

Implication(s): Accelerated Material Deterioration

Task: Improve

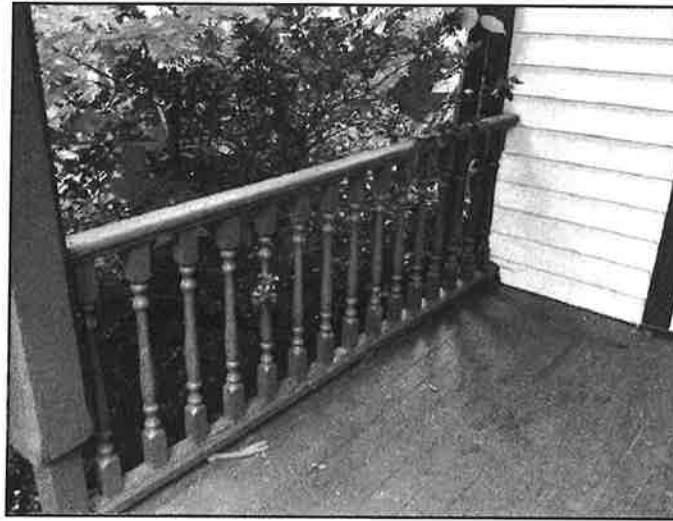
125. Too low

19. Condition: • Too low

Implication(s): Fall hazard

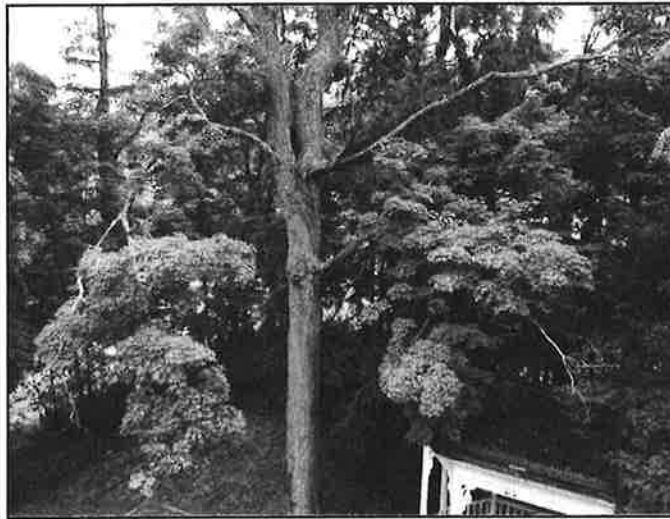
Recommend trimming all trees away from home including any dead wood in yard.

126. Dead Tree Near Home

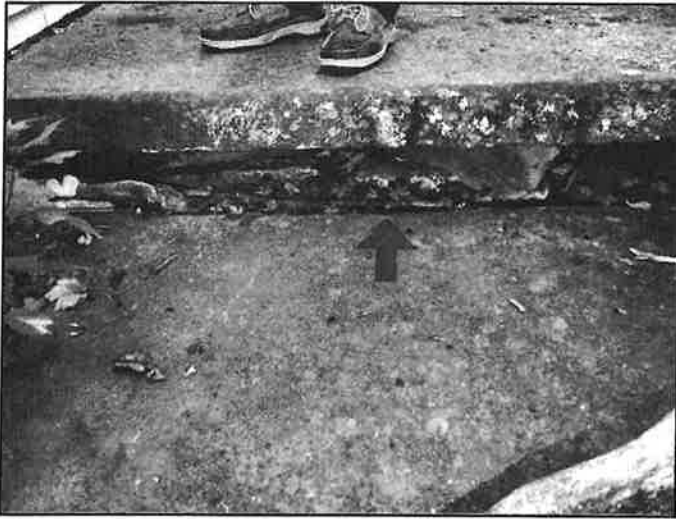
Multiple stone walkways and patios around home in poor condition. Porch foundations have deteriorated / missing masonry. Walkways uneven / slippery. Walkway from garage has multiple loose stones and stair rise / run improper.

129. Deteriorated Masonry

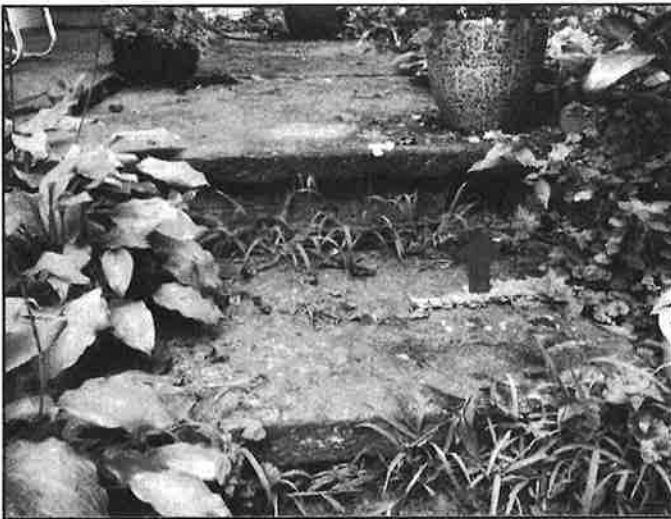
133. Missing Masonry

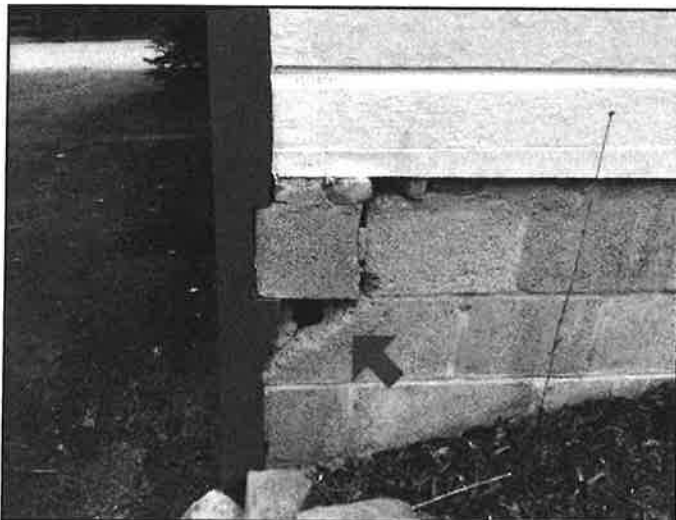
22. Condition: • Garage / guest house in poor condition. Whole building is racked toward street. Multiple large cracks through foundation. Wood siding / trim damaged and missing in places. Flat roof is sagged toward middle. Visible wiring in need of corrections.

139. Damage

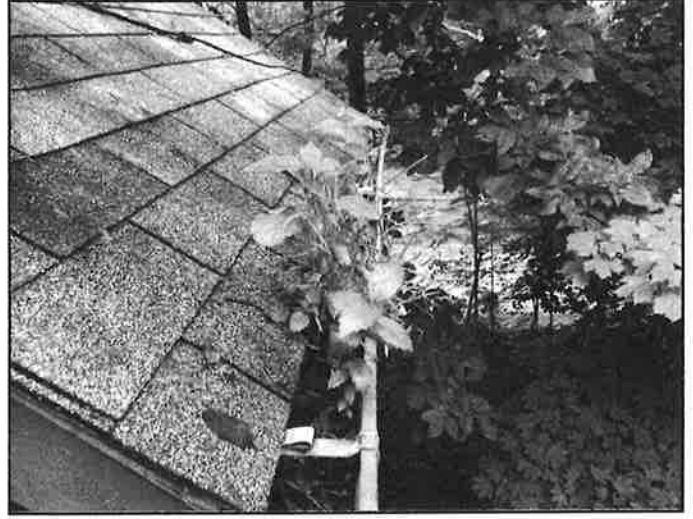
142. Clogged Gutters

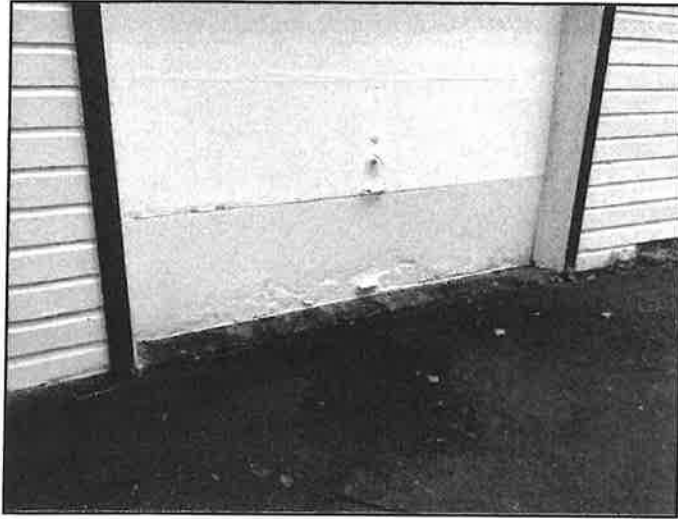
145. *Damage / Inoperable*

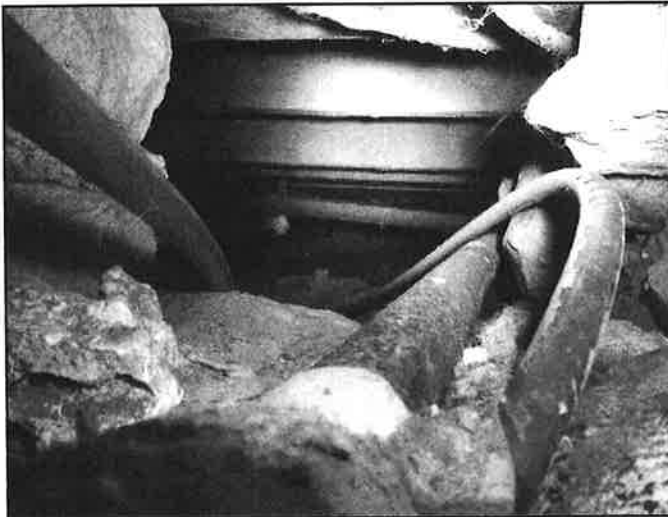
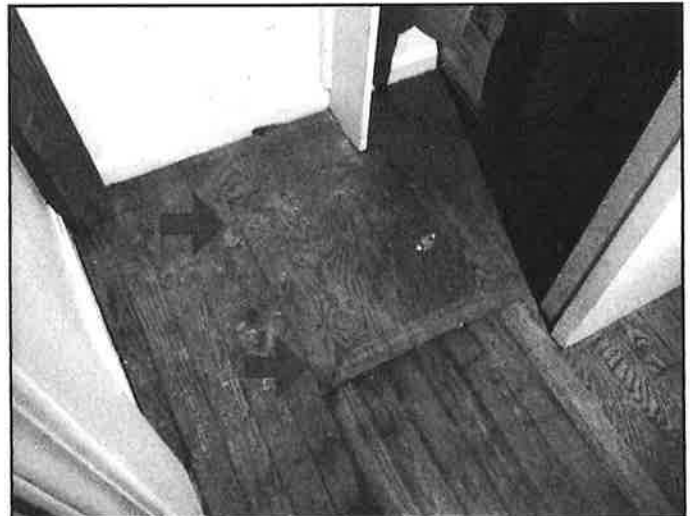
Unable to remove access panel for crawlspace under kitchen.

147. No access

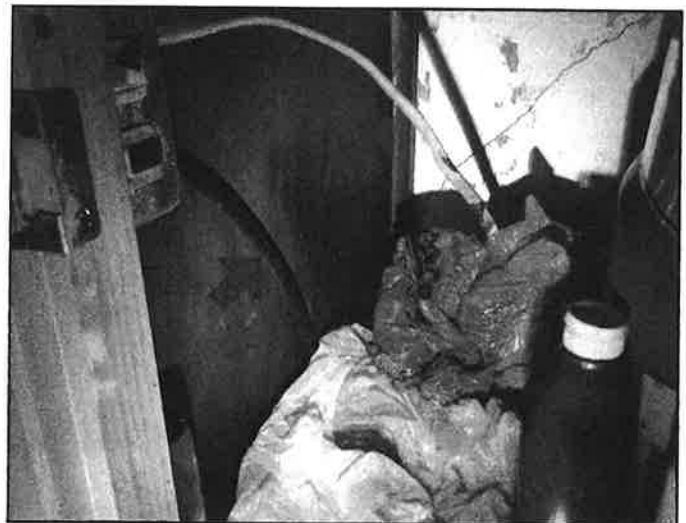
35. Condition: • Exposed on walls or ceilings

166. *Exposed*

167. *Exposed*

Task: Correct

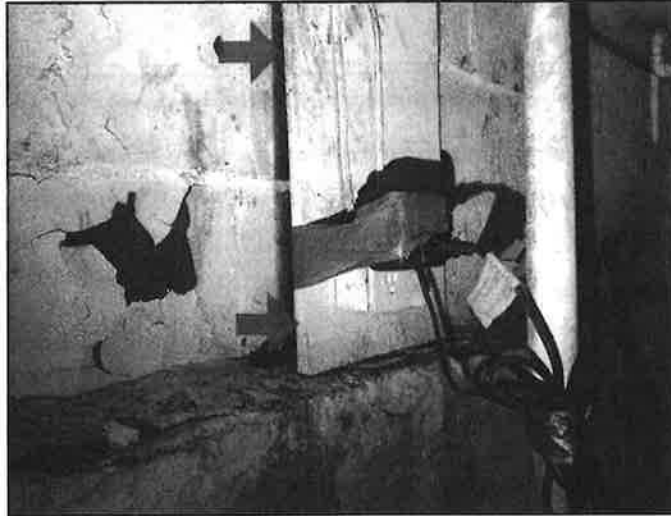
168.

36. Condition: • Board outlet is mounted to is not secured to wall. Exposed wires on board.

Implication(s): Electrical Hazard

Task: Correct

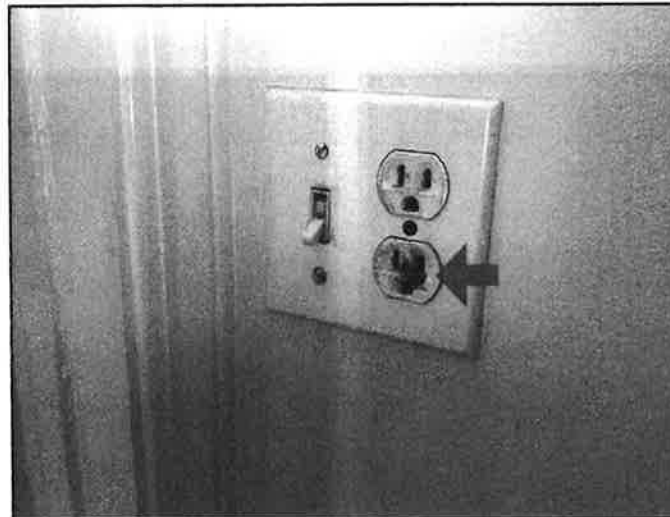
37. Condition: • Damage

Implication(s): Electric shock | Fire hazard

169. *Damage*

Task: Replace

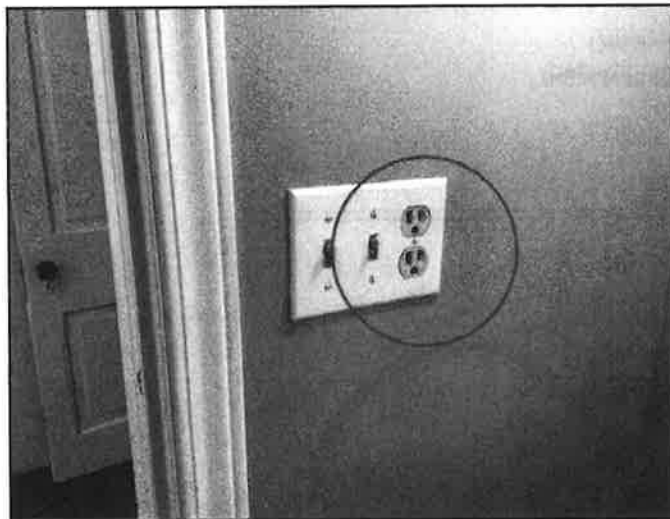
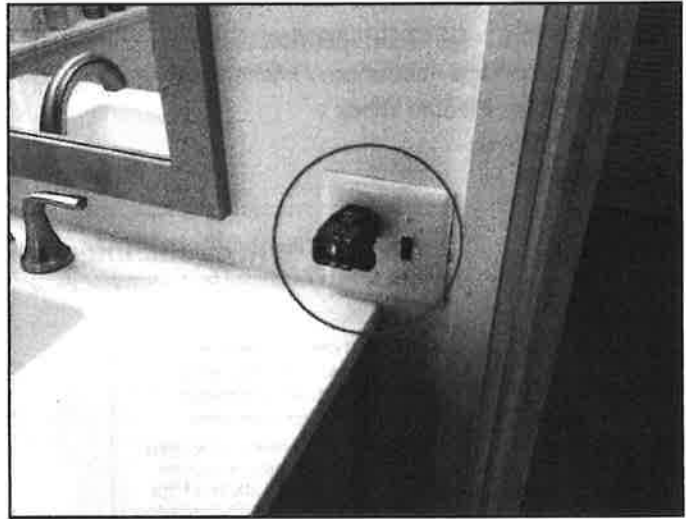
172. Bath

39. Condition: • GFCI/GFI needed (Ground Fault Circuit Interrupter)

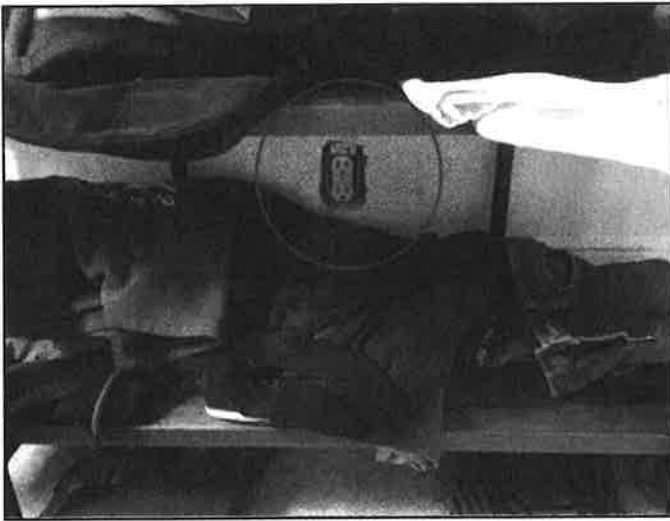
42. Condition: • Missing

178. Missing

Task: Replace

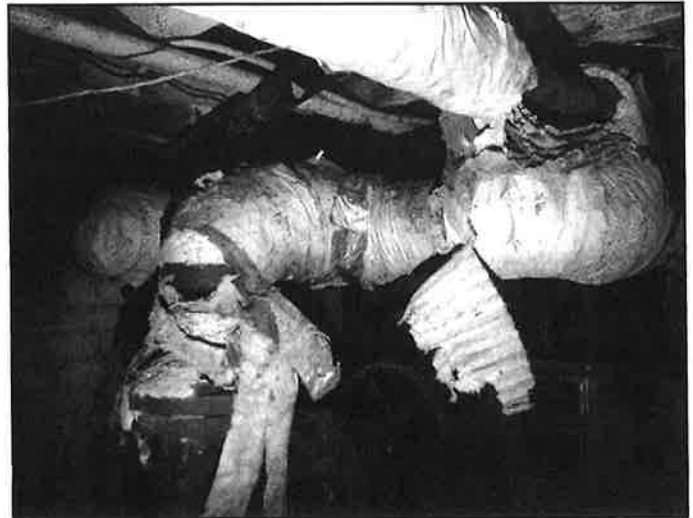
50. Condition: • Probable asbestos wrapping on basement radiator lines. Recommend further evaluation and remediation.

Implication(s): Health Hazard

Location: Various Basement

192. Asbestos

193. Asbestos

Task: Further evaluation

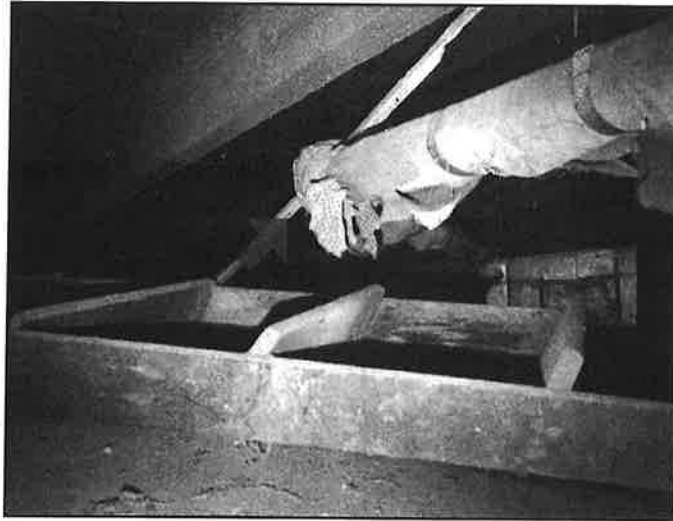
51. Condition: • Appears one of the radiator lines in crawlspace may have been leaking. Pipe is wrapped with rag.

Implication(s): Water Damage

Location: Crawl Space

194. Leak?

Task: Monitor / Repair
