Your Inspection Report

3 W. Summit St.
Chagrin Falls, OH 44022

INSPECTION DATE:
Friday, August 16, 2019

RE: Report No. 1972
3 W. Summit St.
Chagrin Falls, OH
44022

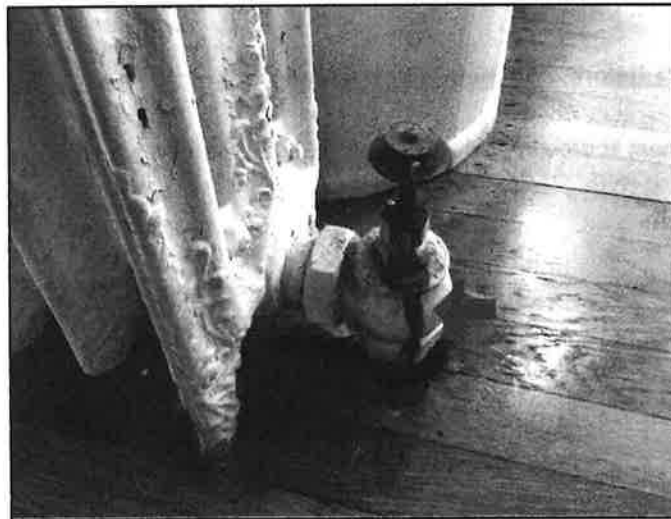
53. Condition: • Leak

One radiator actively leaking. Other radiators with signs of leaks.

Implication(s): Chance of water damage to contents, finishes and/or structure

Location: Various

196. Leaking

198. Stained

Task: Repair

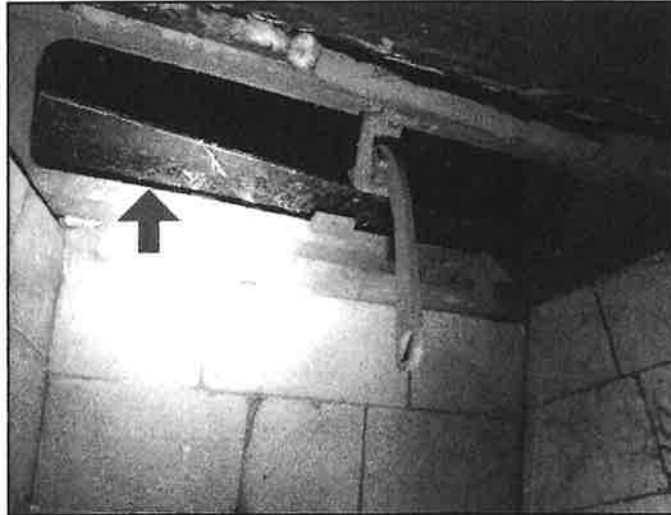
57. Condition: • Inoperative

Implication(s): Hazardous combustion products entering home

Location: First Floor Bedroom

201. *Inoperative*

Task: Correct

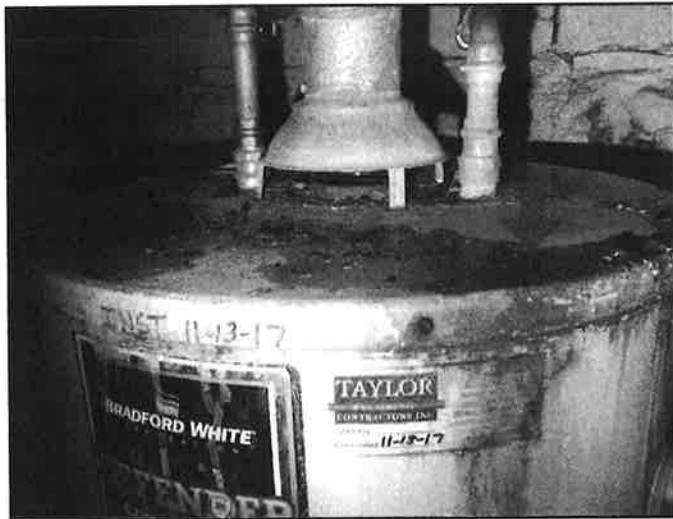
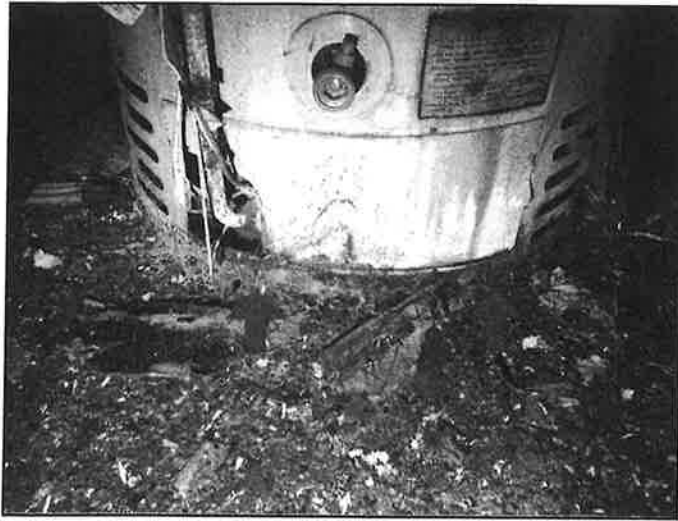
61. Condition: • Rust

Water tank in poor condition for age. Rust noted throughout tank, gas line and vent pipe.

Location: Basement

213. Rust

215. Rust

Task: Monitor

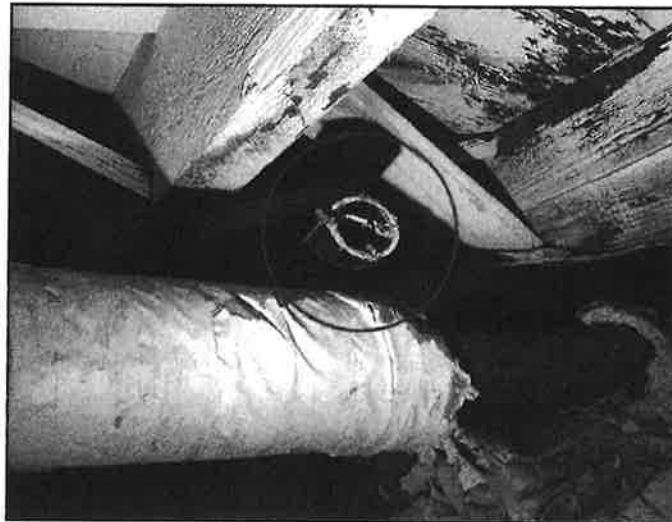
62. Condition: • Poor manifolding of drain pipe

Location: Basement

217. Cap

Recommend capping abandoned drain line that goes through foundation wall near boiler.

Task: Correct

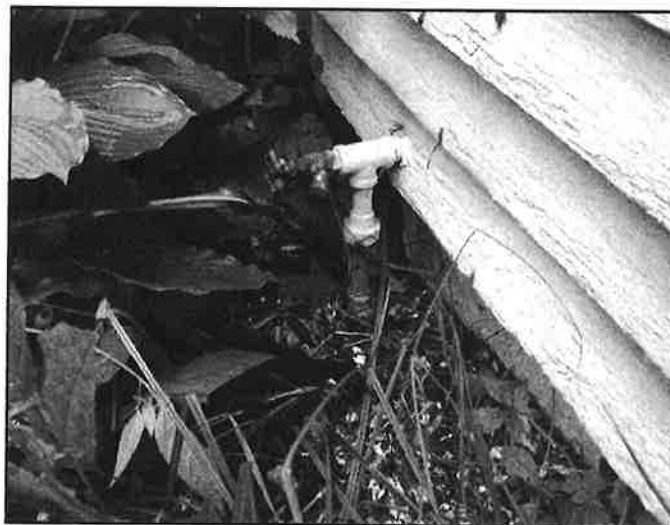
220.

65. Condition: • Water pipe from spigot goes underground to unknown location. Pipe will be difficult to winterize if still in service.

Implication(s): Frozen / Broken Pipes

Location: Exterior

Task: Correct

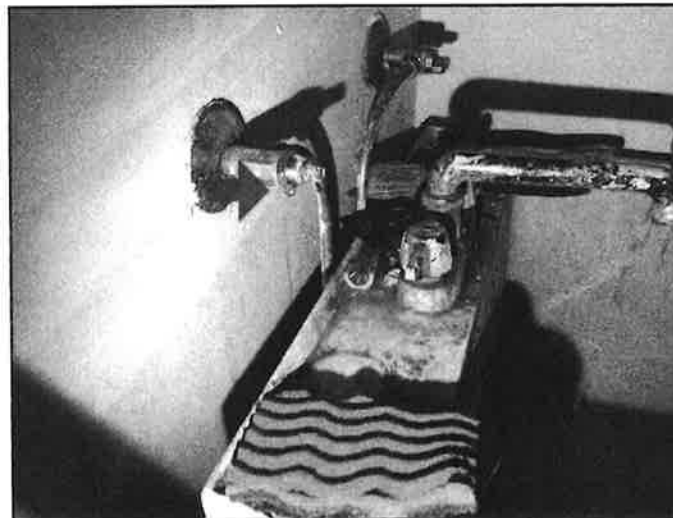
67. Condition: • Drip, leak

Shut off and or faucet are leaking at laundry tub. Shut off missing handle.

Implication(s): Chance of water damage to contents, finishes and/or structure

Location: Laundry Area

223. Drip, leak

Task: Correct

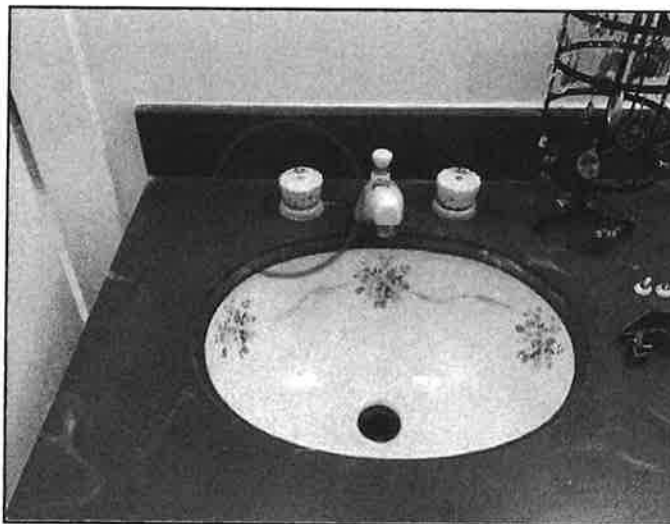
69. Condition: • Stiff or inoperative

Hot water valve inoperative. Sink missing drain stop.

Location: Second Floor Bathroom

225. Stiff or inoperative

Task: Correct

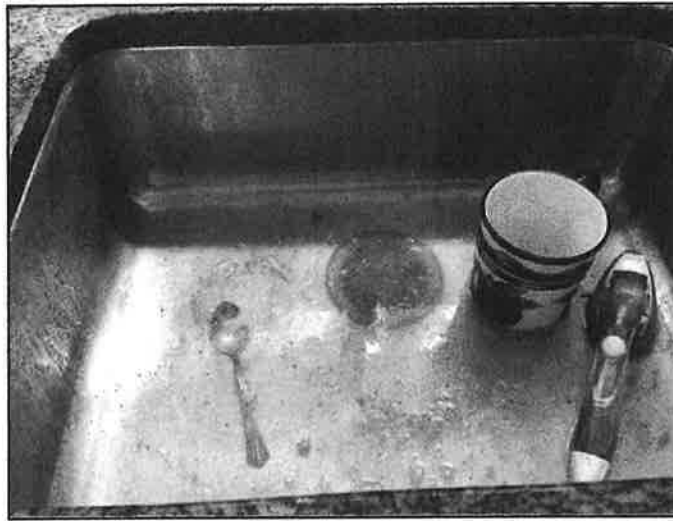
70. Condition: • Slow drains

226. *Slow drains*

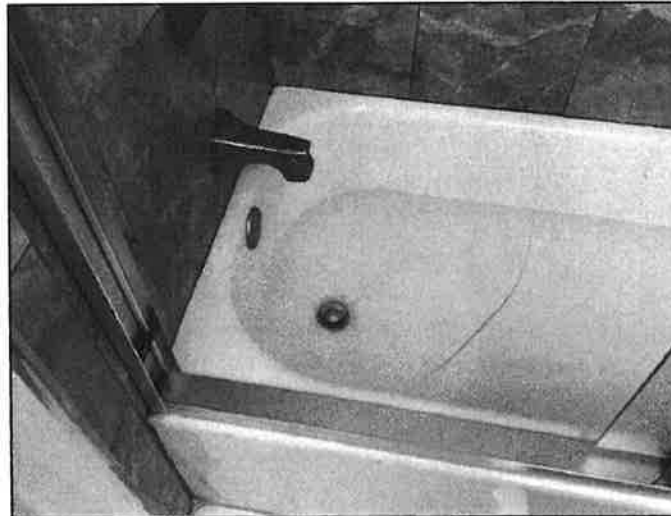
71. Condition: • Slow drain

Implication(s): Chance of water damage to contents, finishes and/or structure

Location: Second Floor Bathroom

227. *Slow drain*

Task: Correct

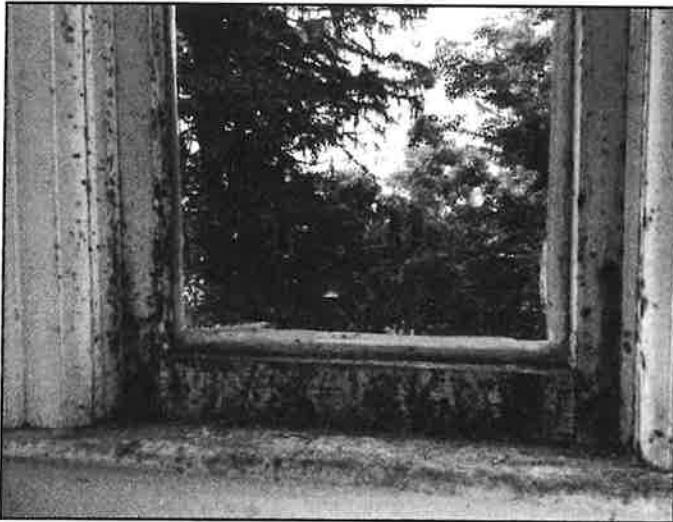
74. Condition: • Possible mold
Probable mold noted inside widows walk.

Implication(s): Health Hazard

Location: Interior Widows Walk

233. Possible mold

Task: Further evaluation / Remediation

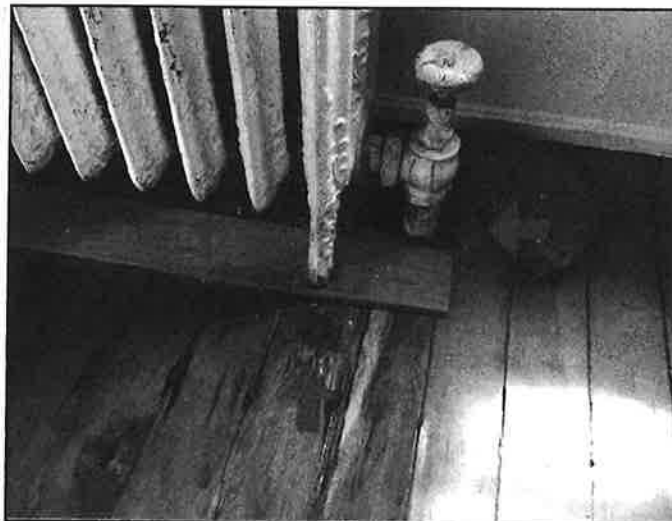
77. **Condition:** • Damage

Radiator leaking most likely cause of damage.

Location: Living Room

240. Damage

Task: Repair

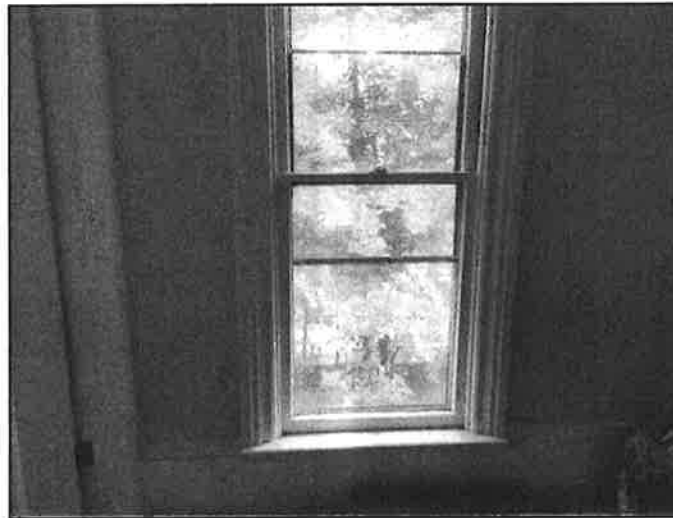
78. **Condition:** • Original lower quality units

Older original units in overall poor condition. Multiple windows inoperable. Various windows with cracked glass.

241. Inoperable

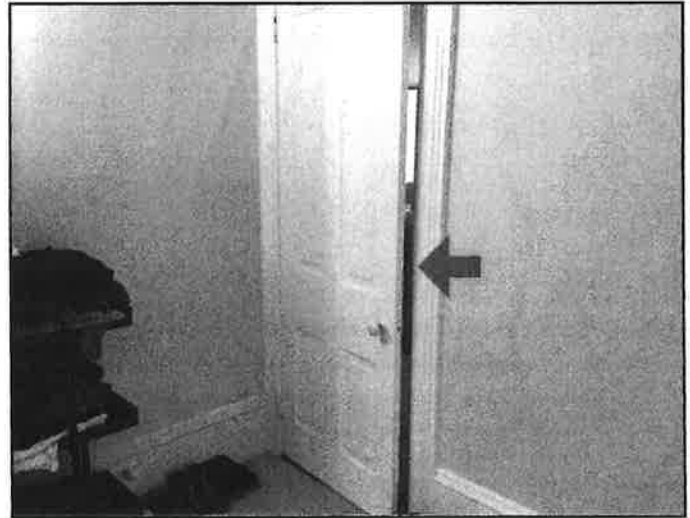
79. Condition: • Stiff

Location: Various

243. Stiff

Task: Correct

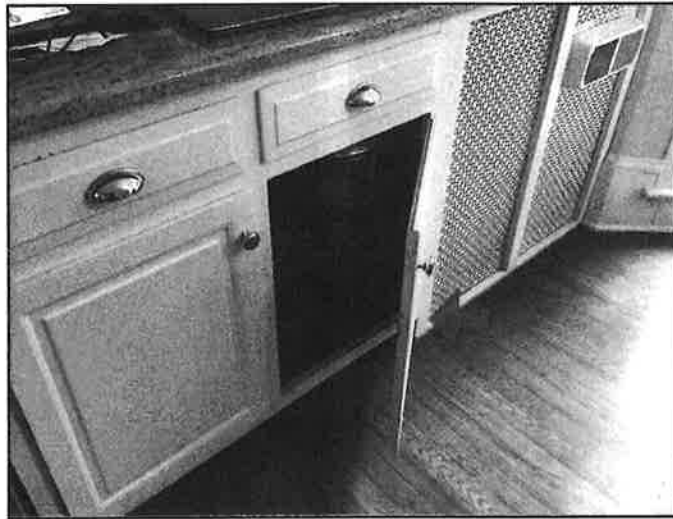
82. Condition: • Defective hardware

247. Defective hardware
